459-465 Exchange Street Dove Block Feasibility Study

May 2017

Prepared for: the City of Geneva and the Dove Block Restoration Group, inc.

Prepared by: **Bero Architecture PLLC 32 Winthrop Street Rochester, New York 14607**

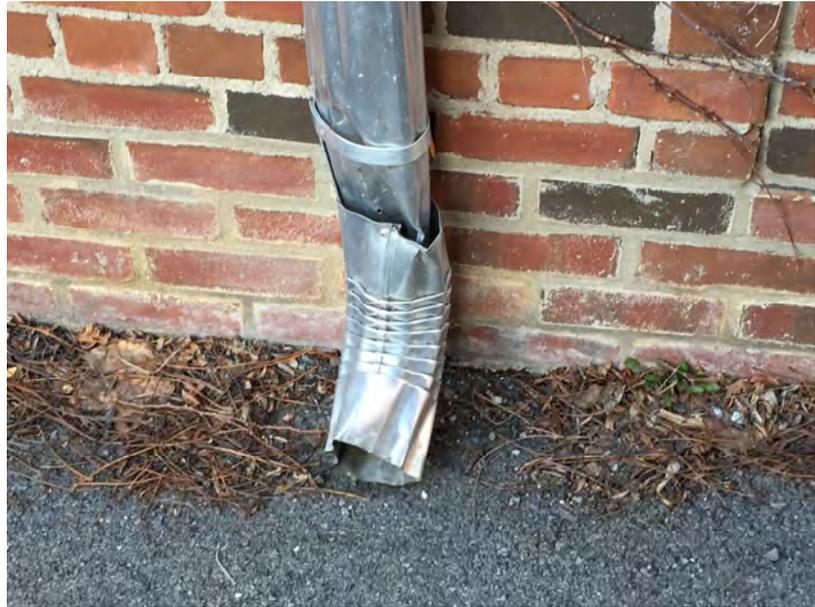
Normal stormwater is collected on the roof by two roof drains at the east, rear, of the building and conducted through interior storm piping installed in 2007 to the City stormwater system. Excess and overflow stormwater is collected in a galvanized steel half-round gutter along east wall and conducted to grade in a galvanized steel downspout and deposited to grade. The downspout has been damaged at grade which is part of the drive connecting Castle Street and the rear parking area. Ideally the downspout would terminate in a cast iron hub and the stormwater conducted below grade to the municipal system. Further study will be required to determine if this is feasible.

Figure 10 – Damaged Downspout to grade

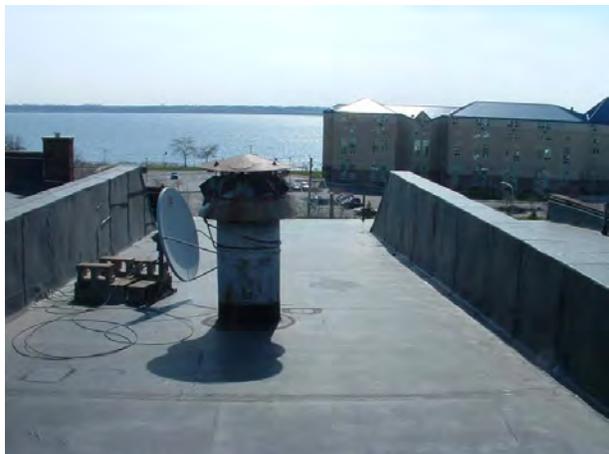
Figure 14 – Center bay looking east –abandoned satellite dish and vent – membrane wrapped trusses.

The original metal gravity vent in the center bay has had its opening stuffed with loose materials. These materials should be removed and a decision on how to address this original element made. It may be possible to incorporate it into a comprehensive ventilation plan. This will help identify an appropriate rehabilitation. Access to the roof is through a loose, manual wood hatch that is covered with EPDM

membrane. This hatch should be replaced with a larger, commercial grade, metal roof hatch coordinated with access from the interior and a security system that is provided by the new occupant.

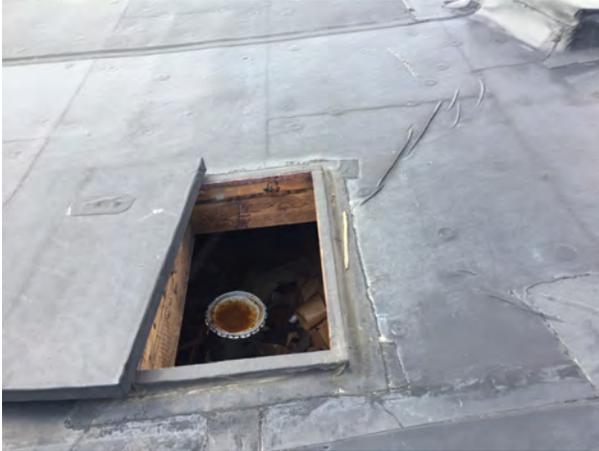
Figure 15 – Manual hatch from attic – north bay east end.

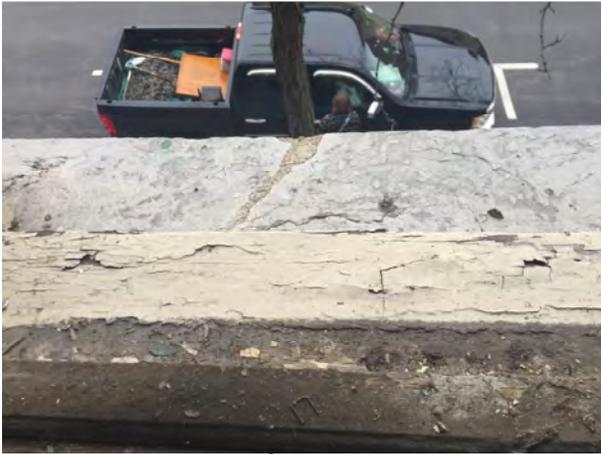
Many of the limestone sills on the second and third floor have levels of failure from tight cracking to large areas of missing material, some replaced by inappropriate patching. Damaged sills should be replaced with new limestone.

Figure 23 – Cracked 2nd floor stone sill

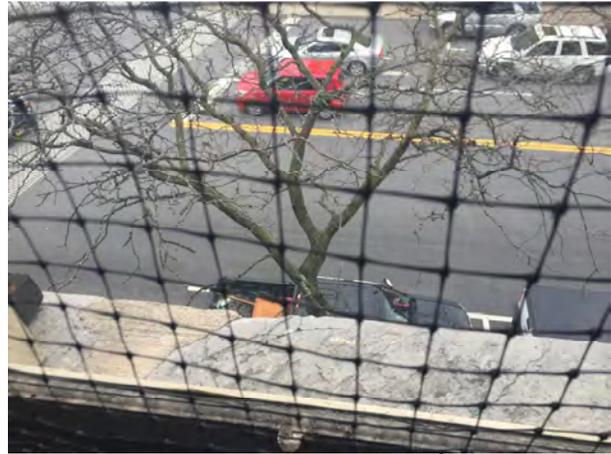
Figure 25 – Patched 3rd floor stone sill

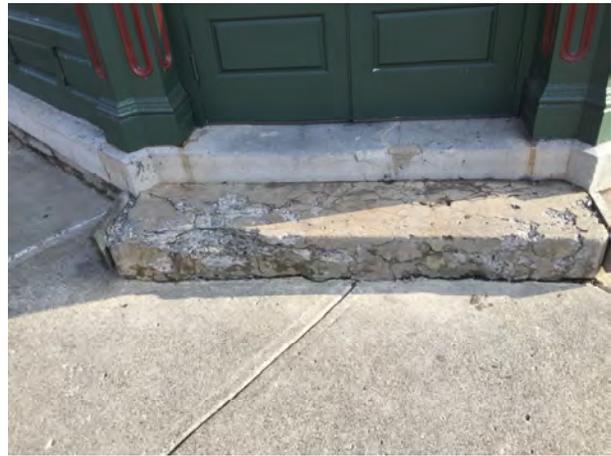
The masonry stoop at the diagonal corner of the building is severely deteriorated with large areas of spalling. This stone should be replaced with limestone.

Figure 26 – Spalled NW stoop

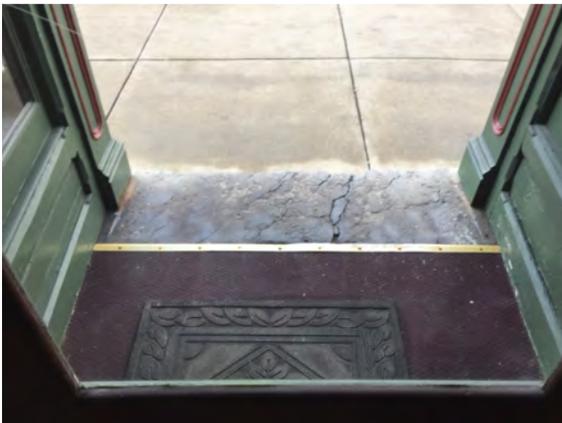
Figure 27 - Deteriorated center bay stoop

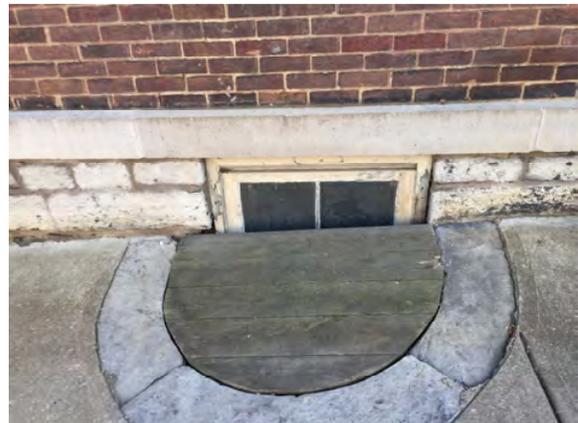
The small area of exposed stone foundation on the north façade is in generally good condition, but has some deteriorated joints that require repointing (Attachment 20).

Figure 28 North façade stone foundation and window well

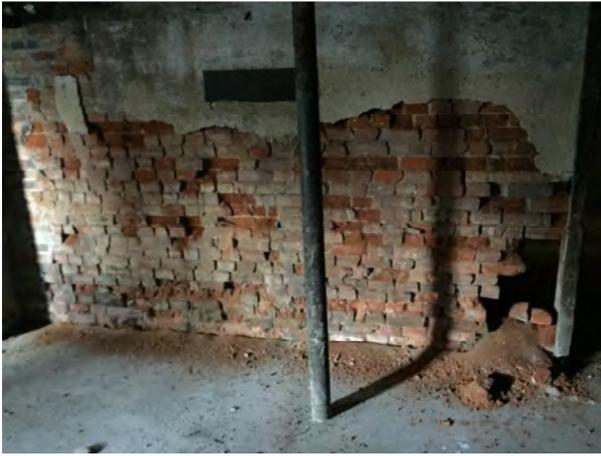
Figure 29 – NE basement interior brick bearing wall deterioration

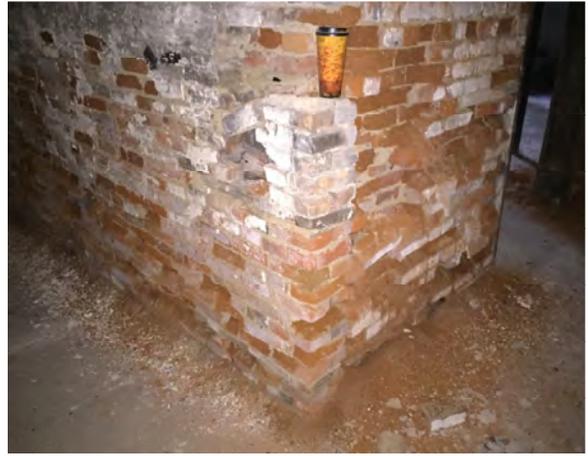
Figure 30 – Interior basement brick bearing wall deterioration

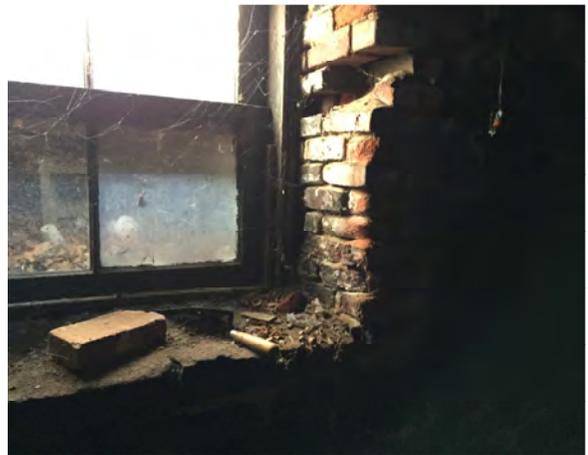
Figure 33 – Basement north wall window – deteriorated brick jamb

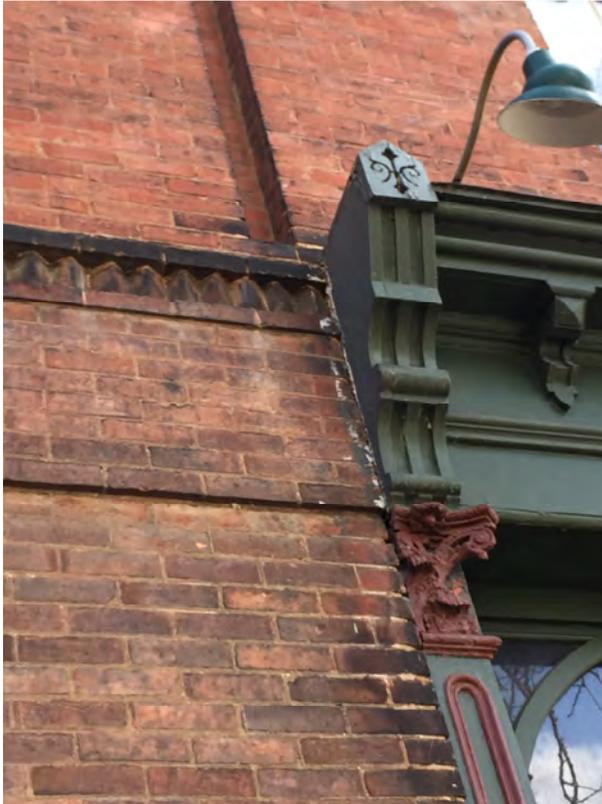
Decorative, painted sheet metal tops the horizontal sign board with a simple projected cornice with metal dentils and brackets. All of the visible sheet metal elements visible from the street appear in good condition. From the second floor windows we observed a sloping sheet metal cap showing signs of rust. The cap should be lightly prepped for rust control and painted.

Figure 47 – Decorative sheet metal storefront bracket and cornice

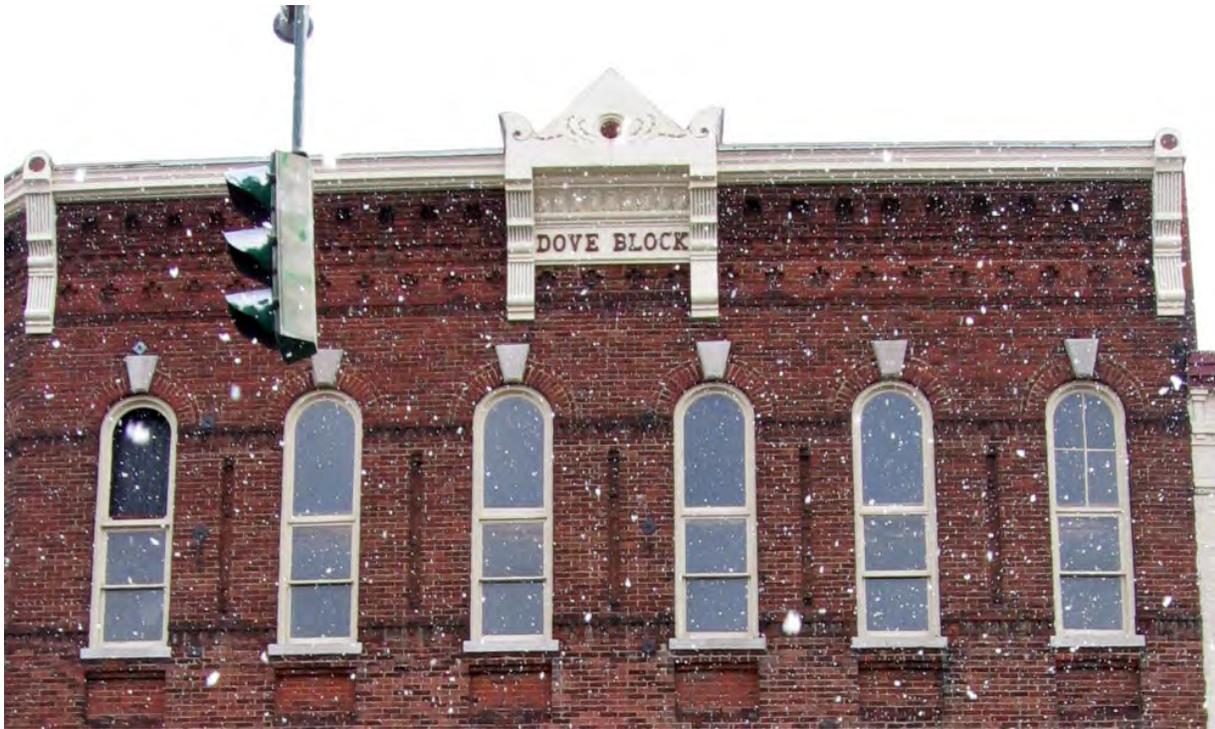
Terminating the two street facades is a simple metal cornice. A large decorative sheet metal pediment flanked by large fluted brackets displays the building name. Large fluted brackets are also located at each end of the two street facades and at the cutaway corner. These elements appear to be in good condition with the exception of the pediment where an open horizontal seam was observed (refer to notes about the Roof above). These elements should be prepped and painted.

Figure 49 – North façade decorative metal cornice, brackets and pediment

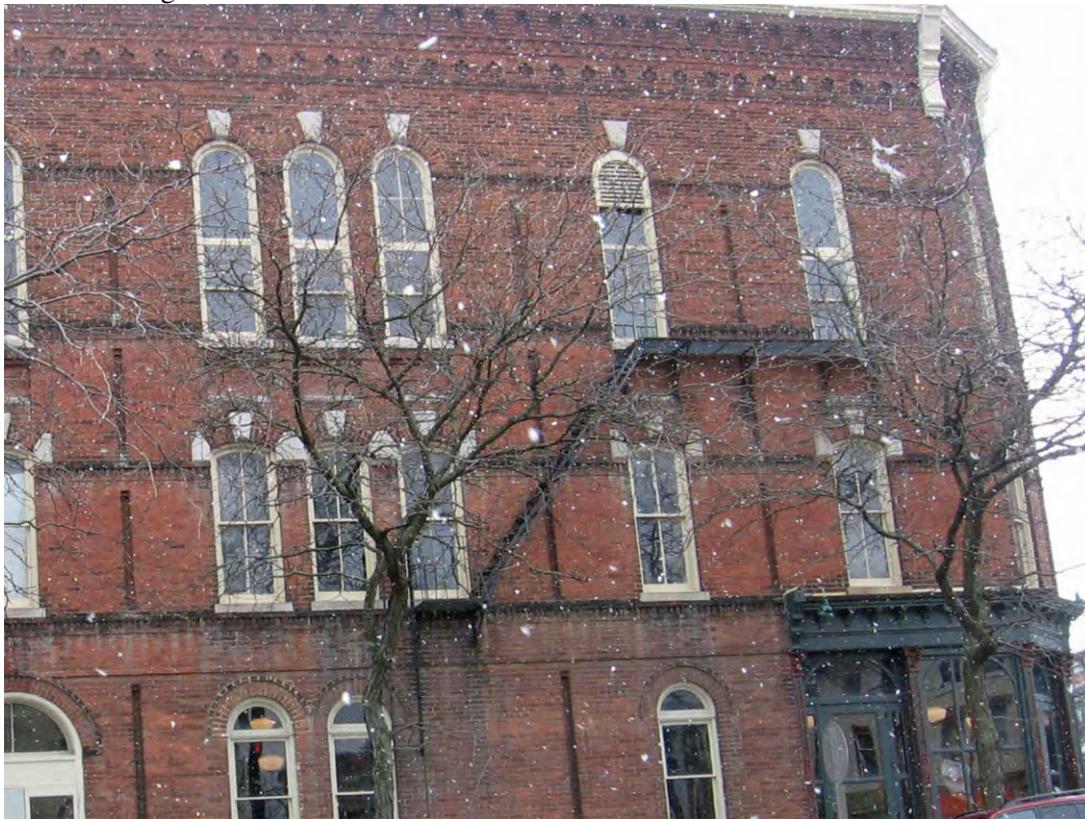
The fire escape, seen in early twentieth century photos, appears to be in good condition and well secured to the building.

Figure 50 – West façade fire escape

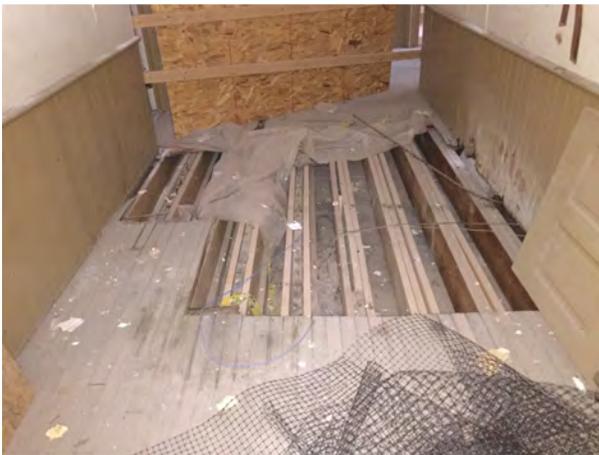
Figure 51 – Second floor center hall damaged floor and wainscot. Also added floor structure.

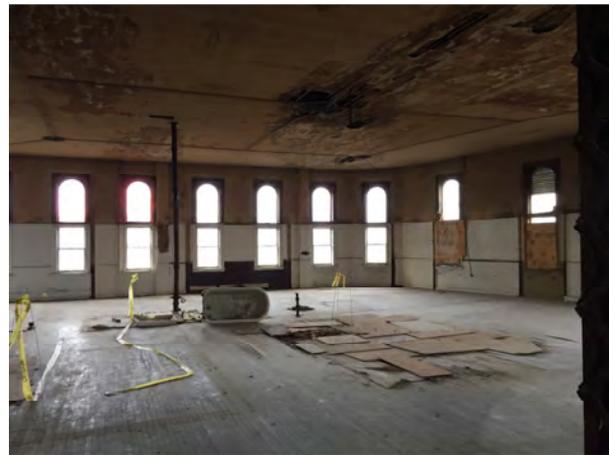
Figure 52 – Third floor center damaged floor and ceiling.

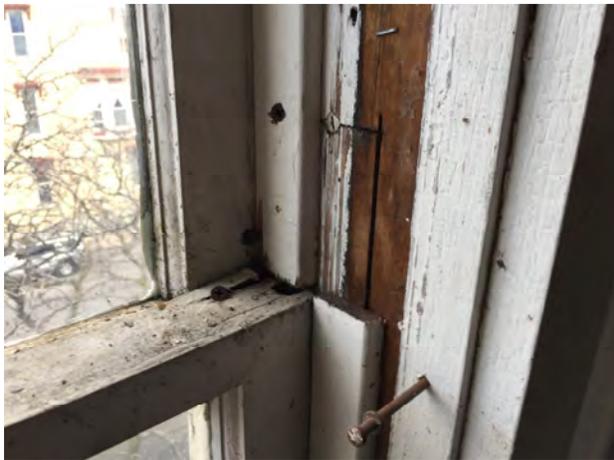
Several exterior wood sills on the second and third floors are deteriorated. Many interior stops are missing. Deteriorated sills should be replaced with a rot resistant wood such as American mahogany, white oak, cypress, or Spanish cedar, be prepared, primed with an oil-based primer, and painted.

Figure 56 – 3rd floor deteriorated, non-original lower double-hung inserted sash

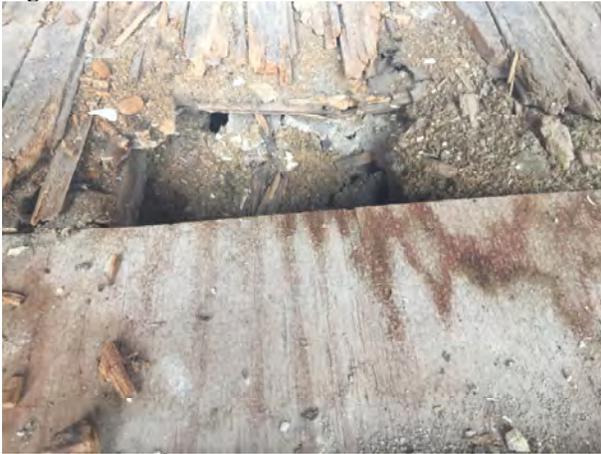
There are several areas of severely deteriorated finish wood flooring and sub-flooring. Areas of deteriorated flooring should be cut back, in rectangular sections, to sound original material. Replacement sub-flooring should be installed in these areas.

Figure 82 – 3rd floor – damaged floor system

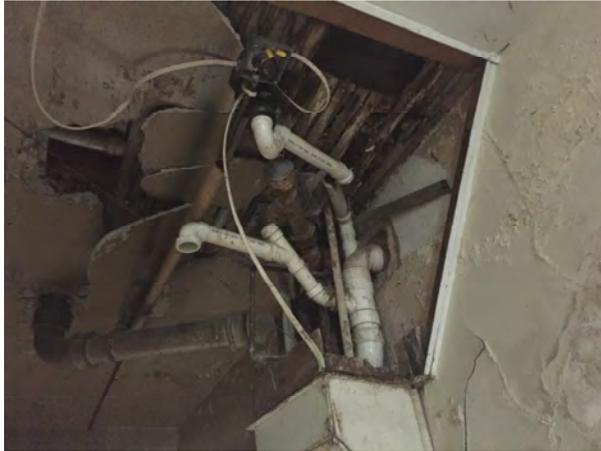
Existing building utilities are insufficient to meet code requirements or expected loading for uses being considered. Existing services will need to be replaced or supplemented.

Figure 86 – Misc added water and sanitary piping
