# Feasibility Study for: Historic Hobart Inn

# BUILDING CONDITIONS ASSESSMENT

Location: 645 Main Street, Hobart, NY 13788  
Project No: 17-131

This report is a reflection of general building conditions that were observed at the time of inspection. Our observations were non-destructive and only based on conditions as they were on October 18, 2017. This included the accessible roof structure, floor and wall construction. We have identified problem areas and concerns with recommendation for repair or suggested further evaluation.

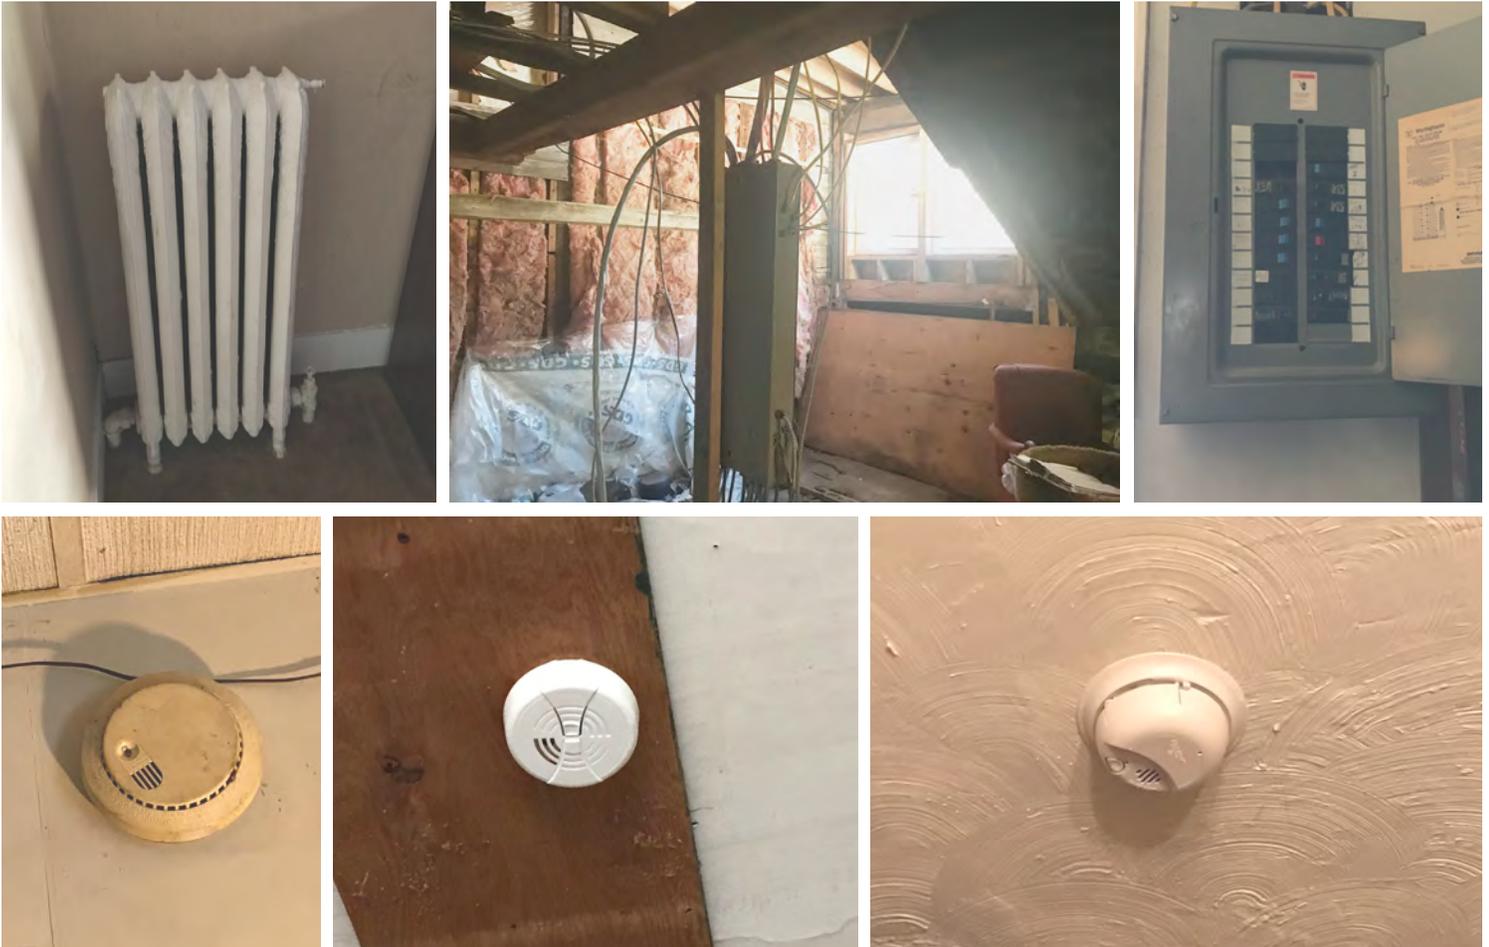
1. Heating: The existing system is hot water from an oil fired boiler in the utility room located on the first floor near the main stair. At the time of our visit, we did not get to see the unit, but we know from our walkthrough that some rooms do not have heat.

2. Electrical: There are multiple electrical panels in the building and it is clear that some electrical upgrades have been done to the building. In some areas of the building there are exposed MC Cable or Romex wires as well as open junction boxes. Most to all of the outlets and switches we were able to see are modern but there are a couple that are not.

3. Fire and Smoke Detection: There are several smoke alarms in the building but they are all battery powered. As of today, the smoke alarm in one section of the building could go off and another in a separate section will not. This is potentially extremely dangerous and is totally dependent upon replacing batteries.

Suggested solution: The existing unit should be serviced prior to the winter to insure that the pipes in the building do not freeze and cause additional problems.

Suggested solution: We suggest that you have an electrical inspector test the grounds for each outlet and inspect each service panel for any potential short circuits or possible overloaded circuits.

Suggested solution: We strongly recommend a whole-building, centrally monitored, interconnected smoke and fire detection system building must be installed.

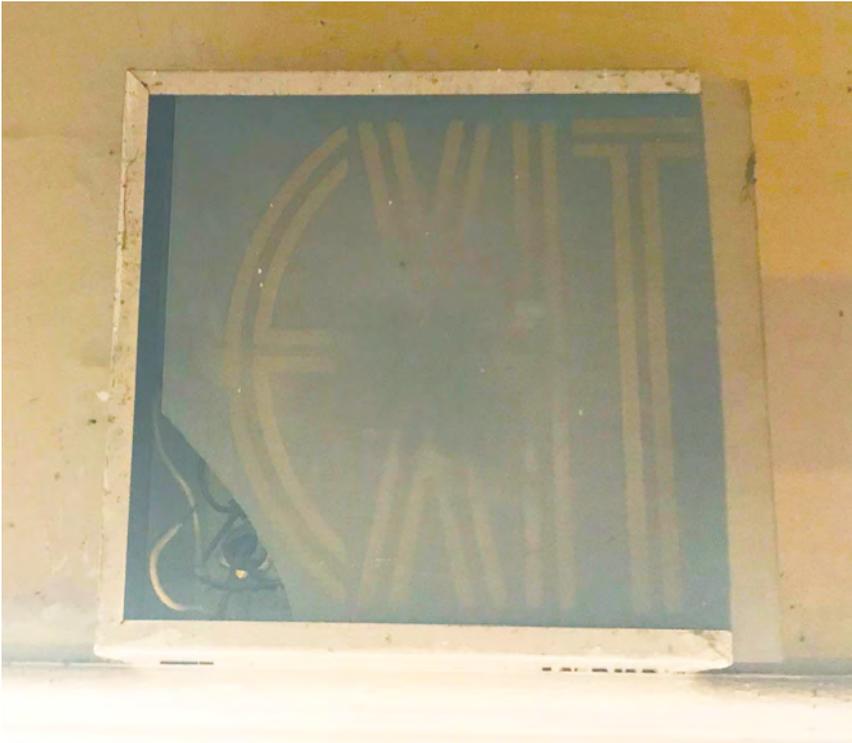
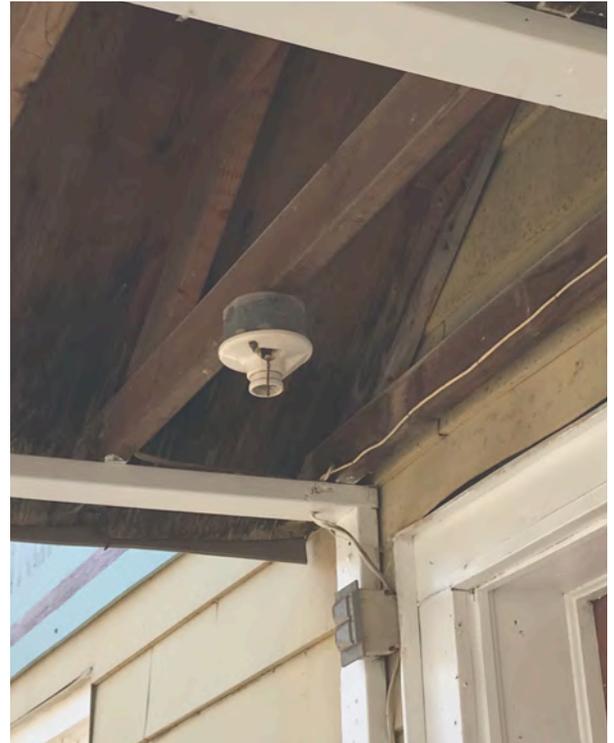
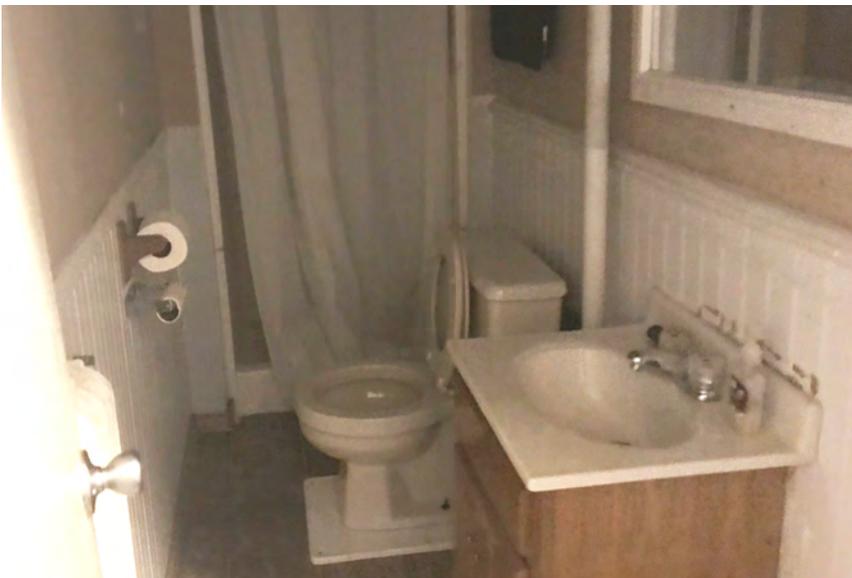
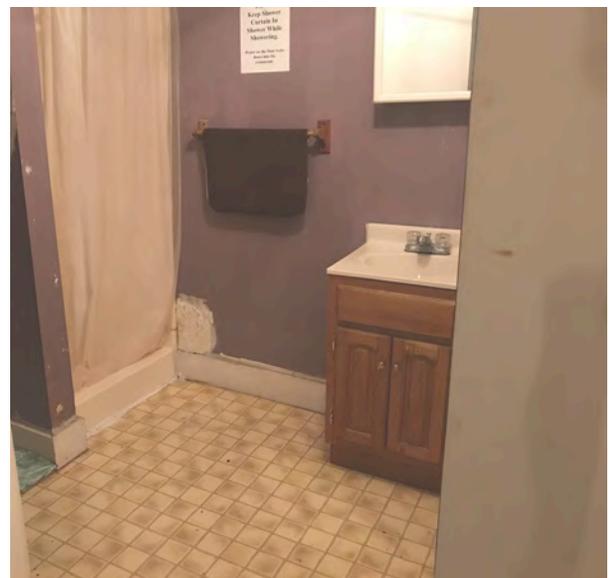
4. Lighting: During our visit, we did not see emergency lighting for egress in case of a fire. The one exit sign we did see was not operational and did not meet the current fire safety standards.  
Suggested solution: Emergency wall mounted light fixtures should be installed to illuminate the halls in case the power goes out. We recommend the EELP Model XTR-1C two headed emergency light that is UL924 listed.
5. Plumbing: The entire building has municipal water and sewer.  
Suggested Solution: Test the water for any potential hardness or particles.

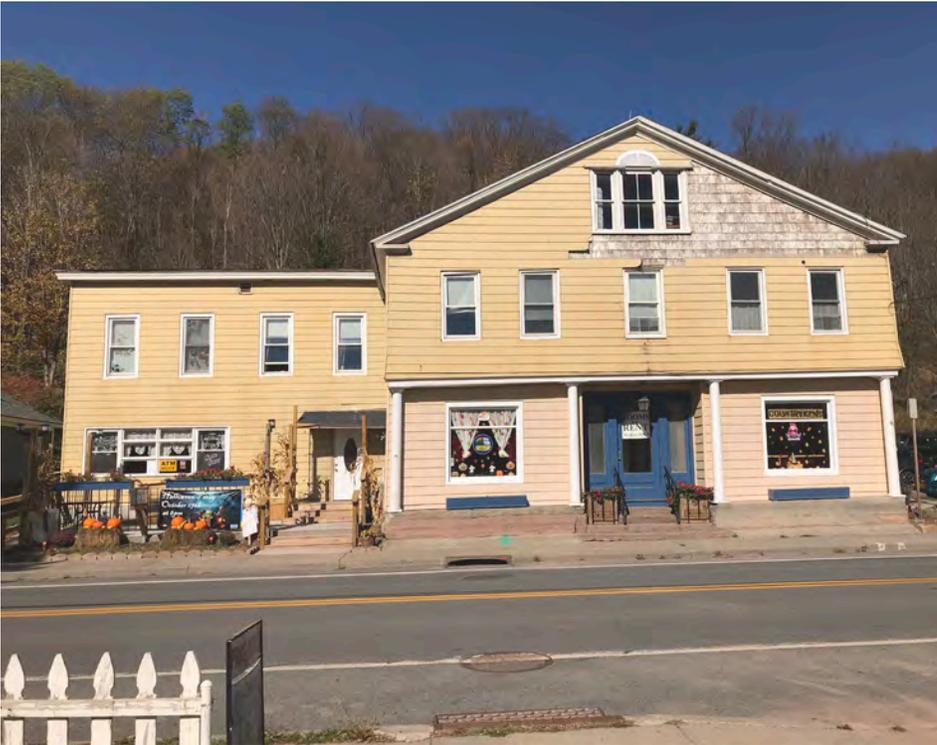
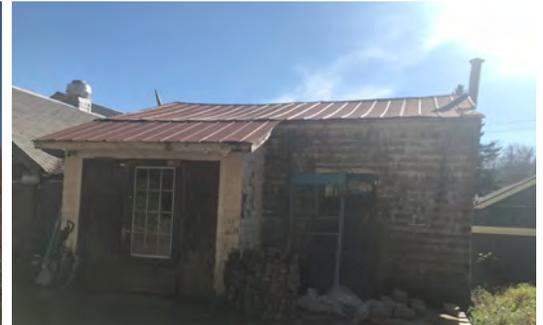
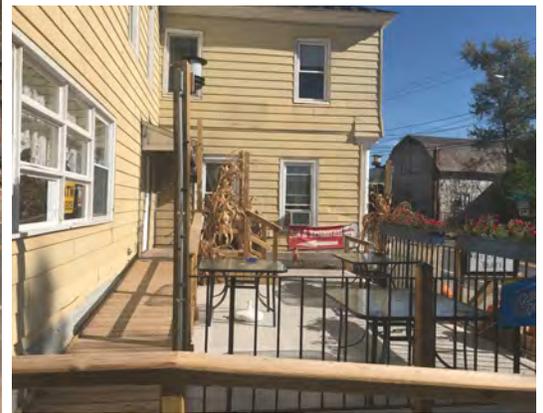
1. The installation of the exterior siding was done poorly. During our visit, we noticed multiple cracks, missing elements and layers of other siding. There are many points of water infiltration at the windows and corners of the building.

2. The existing roof, fascia, gutters and soffits are in poor condition. There is clear evidence of water damage and rotting material. The longer this issue goes unattended, the worse the core structure will become. There are visible leaks within the building as well as water damage in the ceiling.

3. There are areas of the foundation that have been repaired given water infiltration. The water needs to be directed away from the building. If the gutters are installed and leader extensions are added water from the roof will not go near the foundation. Surface water can be directed away from the building by insuring the site slopes away from the building.

4. Many of the doors and windows have been replaced over time. The detailing around the windows and doors could be improved when the siding is replaced.

Suggested solution: Remove all layers of the existing siding, install new sheathing and exterior insulation, then add new, pre-finished fiber-cement siding and trim.

Suggested solution: Remove all existing roofing material and replace damaged sheathing. Rebuild overhangs as necessary so that new gutters and leaders can be installed. At the very least, new gutters and leaders should be installed to direct the water away from the building as soon as possible. We would suggest exterior insulation prior to installing new roofing.

Suggestions: New gutters and grade the site especially near the kitchen.

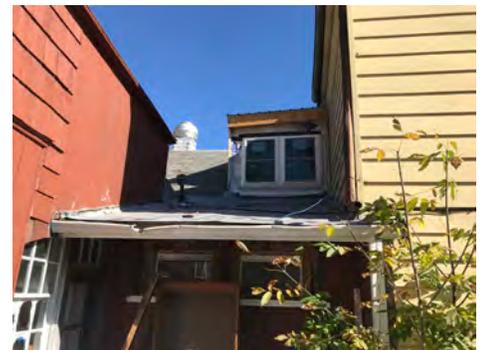
New dormer and exit from the kitchen.

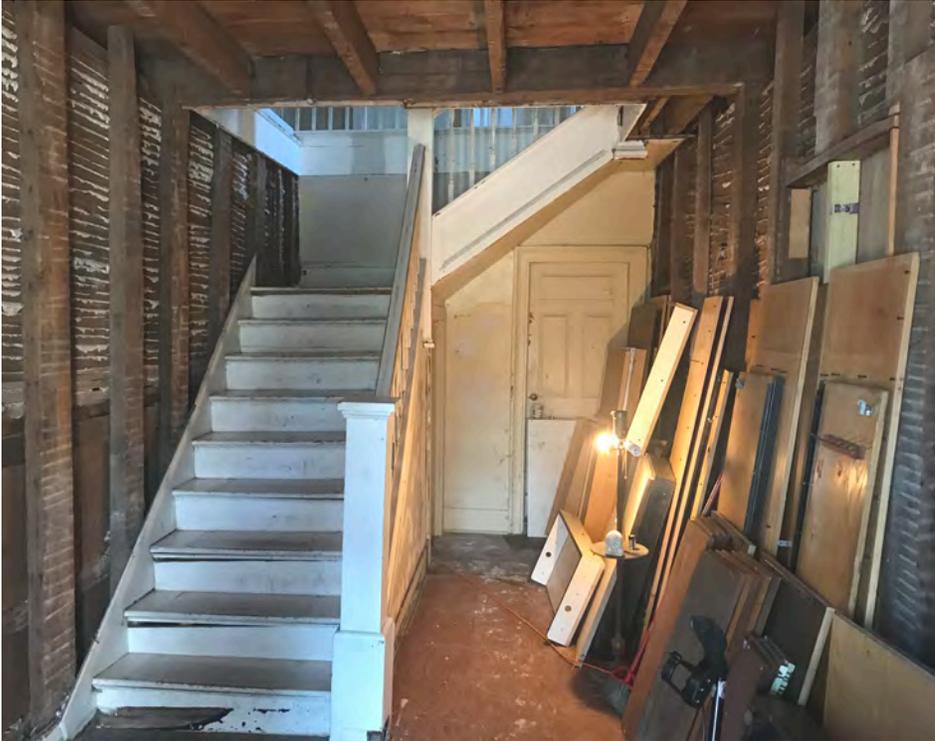
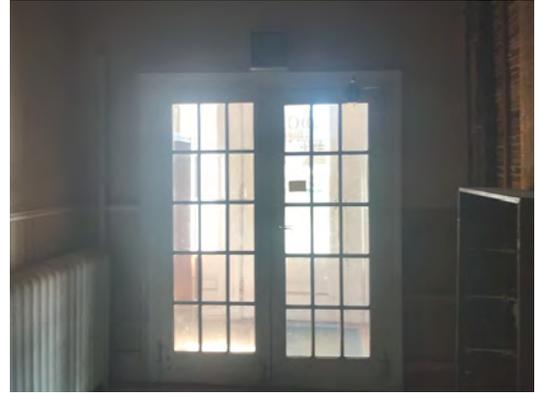
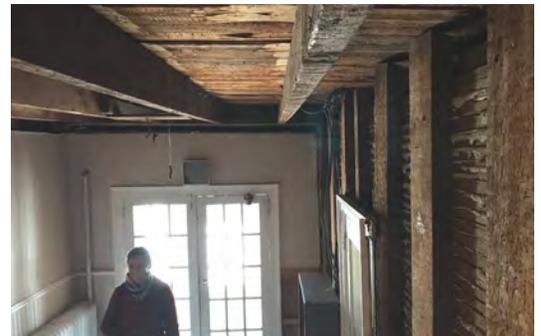
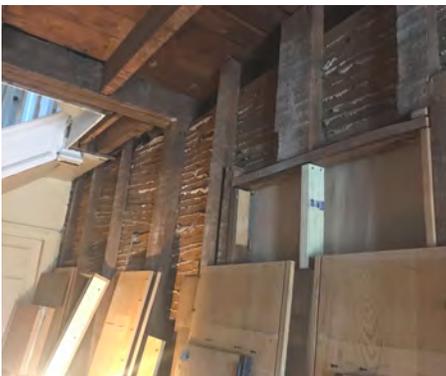
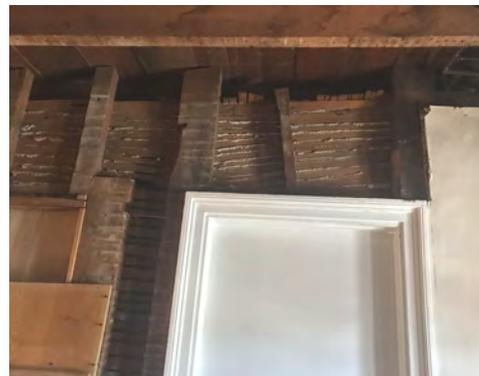
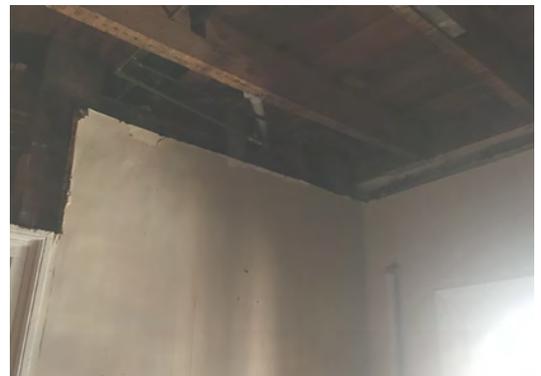
1. The main entry for the Inn is unfinished and cluttered. The masonry stairs and railings to the entry need repair.  
Suggested solution:
  - Add furring to the existing walls and ceiling with the entry then finish with gypsum board
  - Install new railing for the exterior stair.
  - Remove clutter.
2. The stairs are not up to code and are in poor condition. The bottom of beam height is no taller than 5' - 6." This could cause many injuries to anyone who is taller than that height.  
Suggested solution: Demolish and rebuild stairs to be code compliant.
3. The balance of the first floor includes the restaurant and retail shop. We walked the restaurant at the end of our day and did not see anything unusual. We were not able to get into the retail shop.

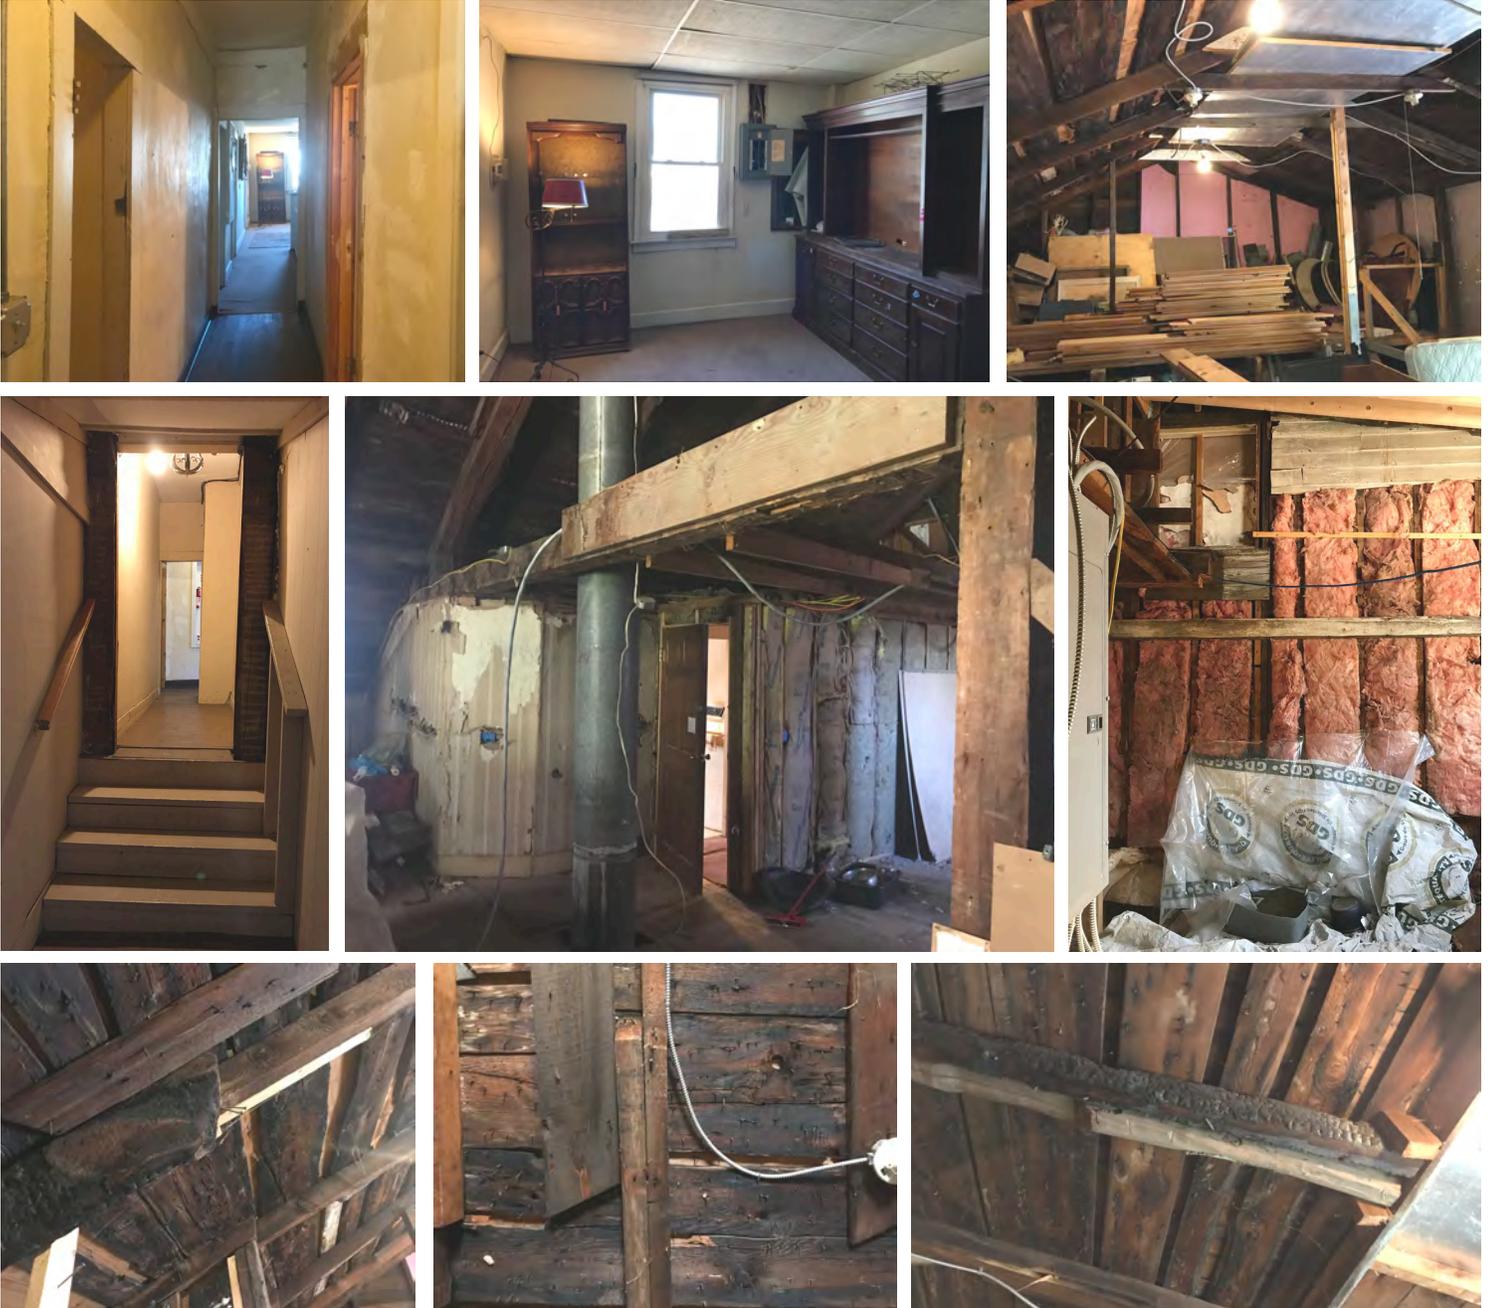
1. The second floor has three separate areas. We recommend a complete demolition of the original “shed” structure that is used for storage on the second floor and has a small room with an exit on the first. We were not able to get into the first floor room during our visit. This portion of the building needs to be completely rebuilt from the foundation to the roof. Other important issues we found was fire damage on the main rafters, the exterior wall framing and roof framing are in poor condition and there is no insulation within walls or roof. The foundation it is in poor condition because of water infiltration.

Suggested solution: Remove and replace the existing portion of the building.

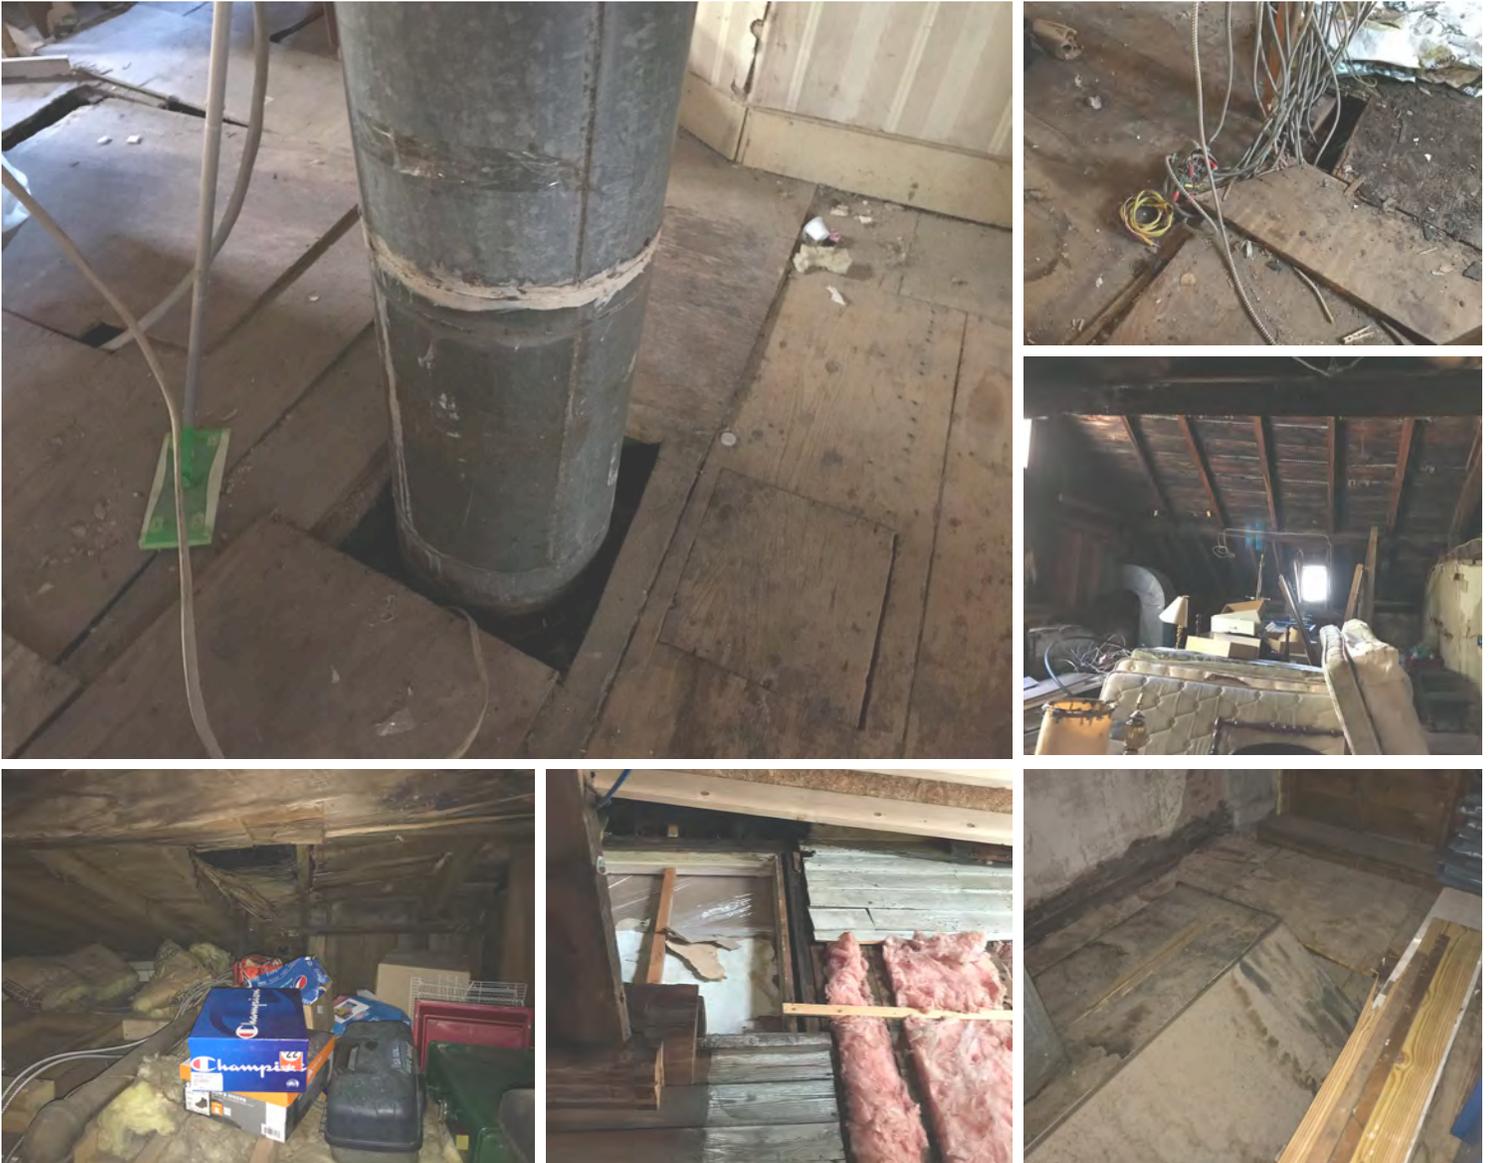
2. The timber framed portion of the building that contains the common kitchen and laundry is in better condition than the shed structure. We recommend stabilizing that and potentially using this area for the Inn. The majority of the space is used for storage. There are three major concerns with this space in general. The most critical issue with this space is the lack of fire separation between the kitchen hood and the room above. Given the lack of ceiling height in the kitchen below, the hood penetrates into the floor system. Therefore, there is no fire separation and grease can build up which will create more of an issue in the future. The floor system for the entire area is in poor condition and must be replaced prior to any alterations. There is an active water leak from the dormer that was recently repaired, but needs to be repaired again.

Suggested solution: We would recommend a new floor structure be built over the existing. We could design a TJI floor system that could clear span over the existing. Once the new floor system is installed the appropriate fire separation can be put in place. The roof structure and wall construction is in fair condition.

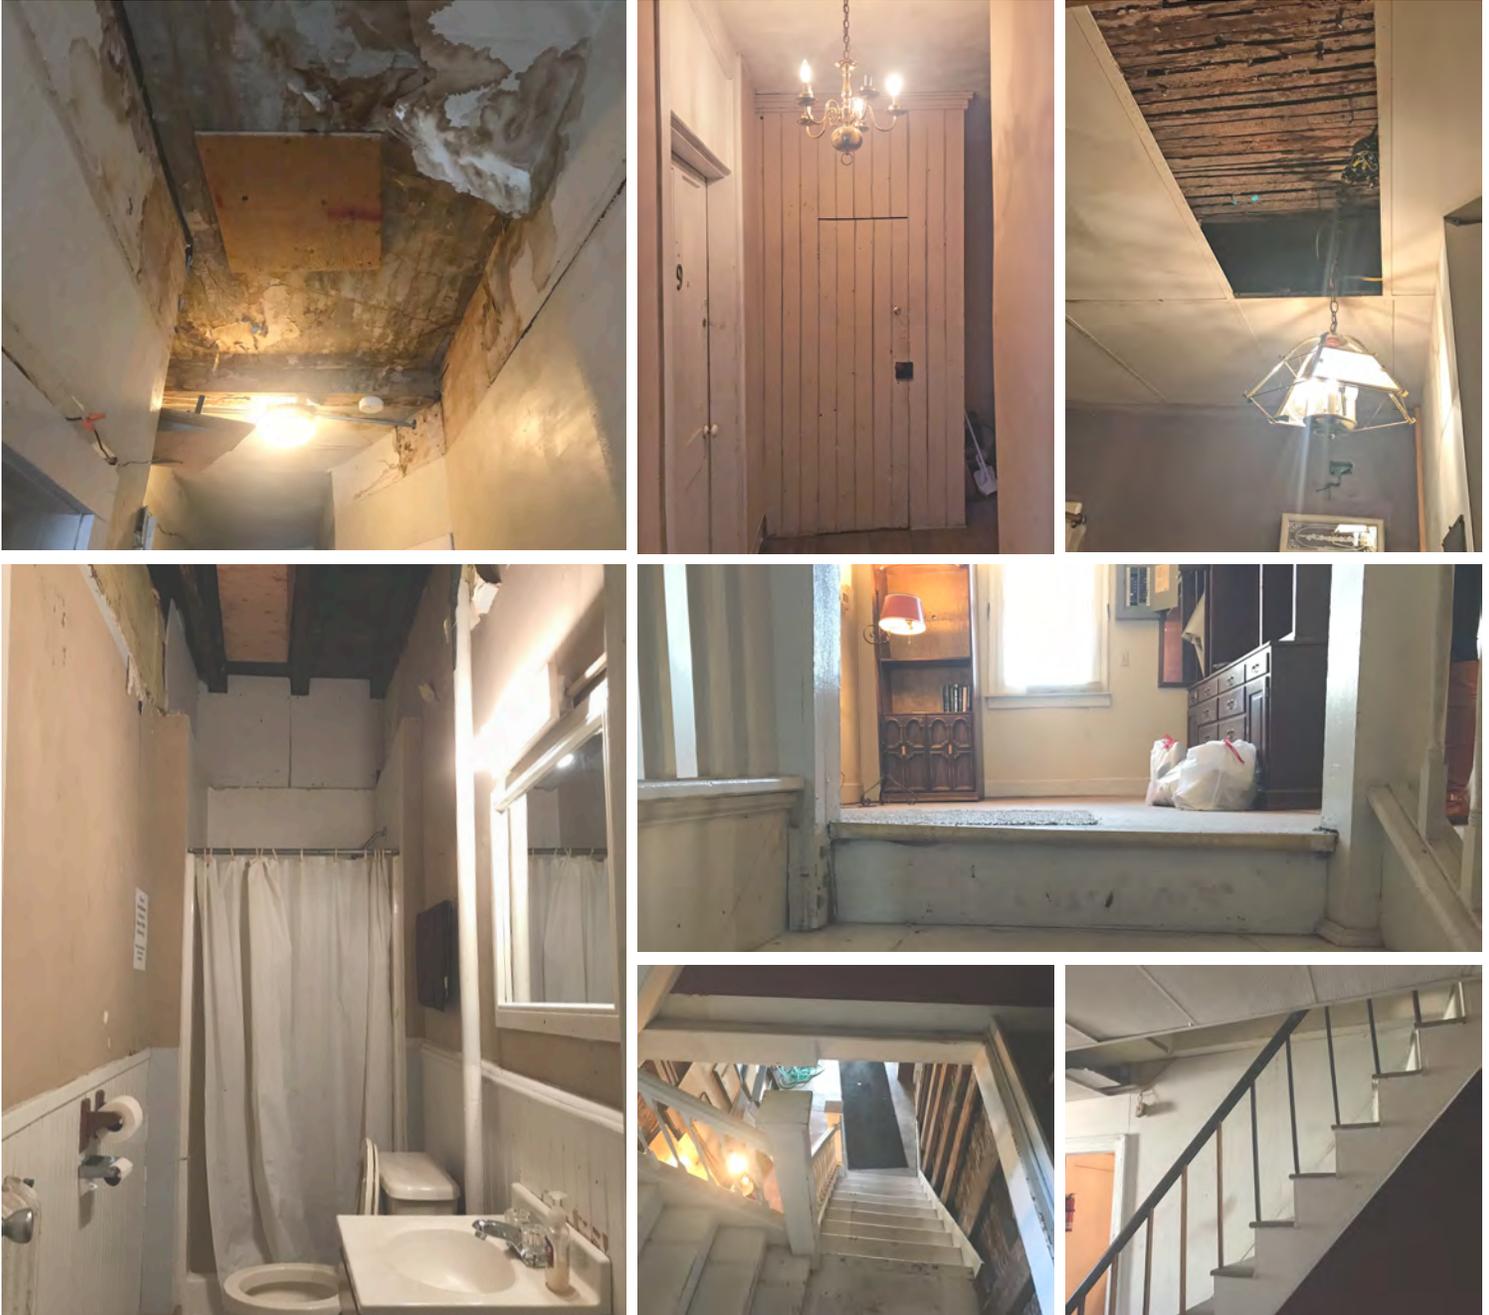
3. The second floor walls and roof construction housing the existing Inn rooms are in fair condition, but there is a lot of water damage on the ceiling from a leaky roof. The exposed electrical wiring should be inspected and covered. The floor itself is slanted in multiple directions. The main stairs are in need of replacing and the attic stairs should be removed.

Suggested Solution: The first priority for the building should be installing proper emergency egress for the occupants. We are strongly suggesting you install emergency lighting and exit signs, as well as a whole building interconnected centrally monitored smoke detection systems. We would also recommend the stairs be built at a minimum head protection and caution signage for the stair.

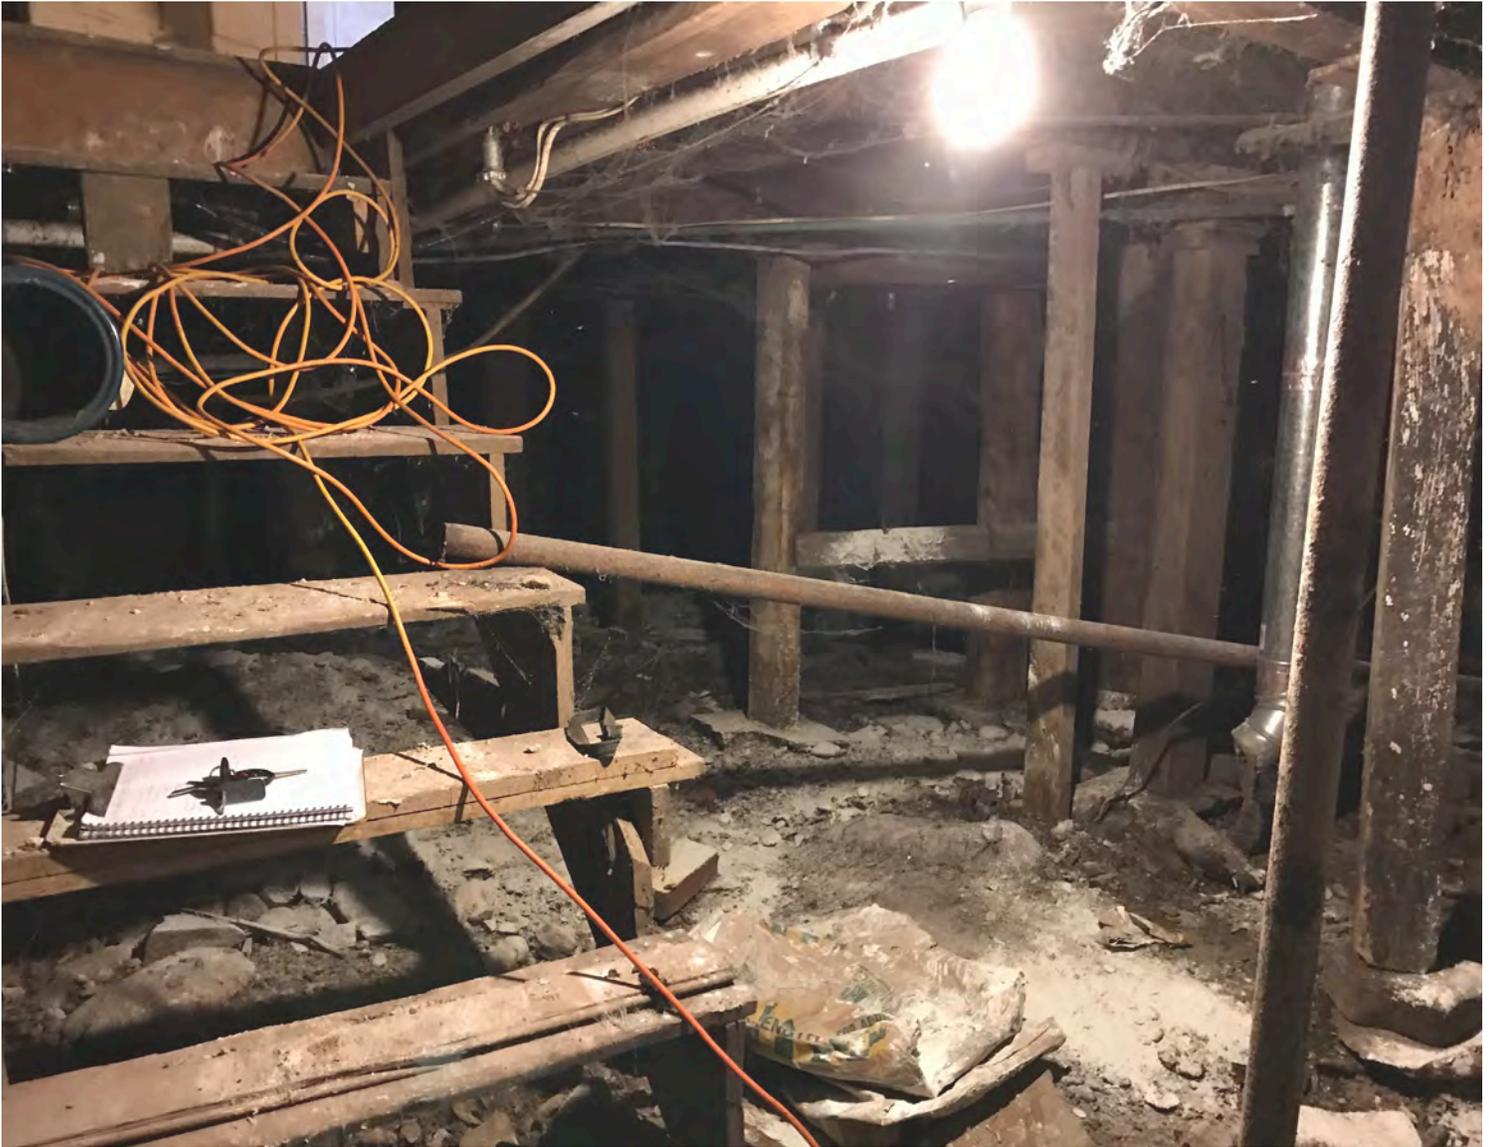
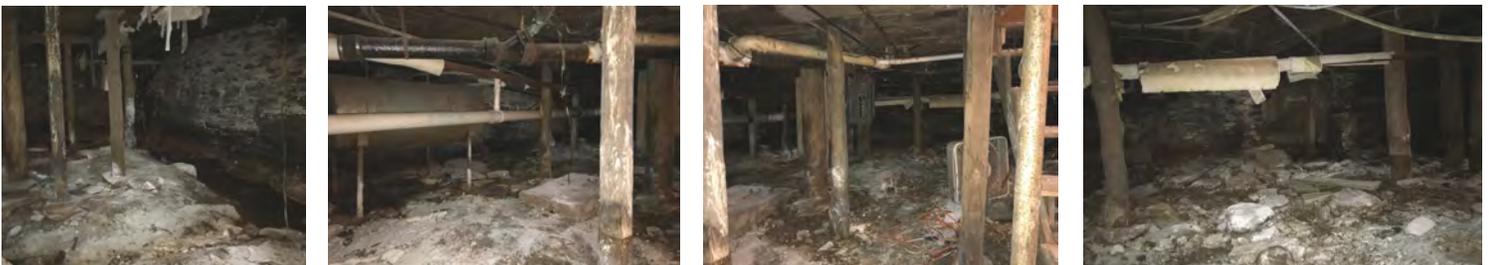
1. The only portion of the basement we were able to get in had a very low ceiling with a dirt floor and stone walls. The basement had water pools in multiple areas and visible mold. Some of the pipes were insulated and at the time we could not see if they could be asbestos wrapped or not.

Suggestion: The basement should be cleaned out and further evaluation should be done to prevent water infiltration. Mold remediation should be also recommended.
