459-465 Exchange Street Dove Block Feasibility Study

May 2017

Prepared for: the City of Geneva and the Dove Block Restoration Group, inc.

Prepared by: **Bero Architecture PLLC 32 Winthrop Street Rochester, New York 14607**

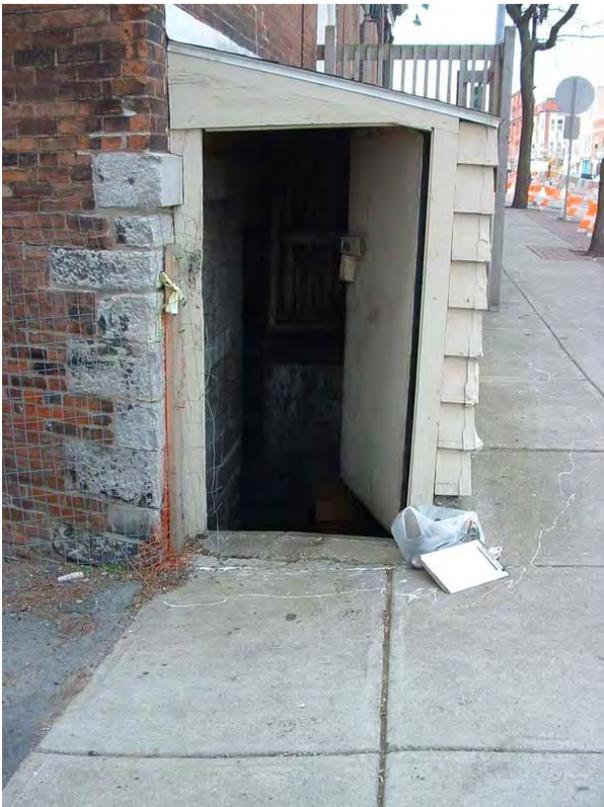
Figure 6 – NE Basement Frame Enclosure

- Structural Repairs primarily to meet current code requirements
- Exterior improvements including window repair or replacement, replacement of Castle Street porch and basement enclosure, and refinishing painted elements
- Interior improvements and finishes at exterior walls, ceilings, floors, and egress elements
- Mechanical/Electrical/Fire Safety – New water service and back-flow preventers, new electrical service, basic sprinkler service, emergency lighting and fire alarm system.

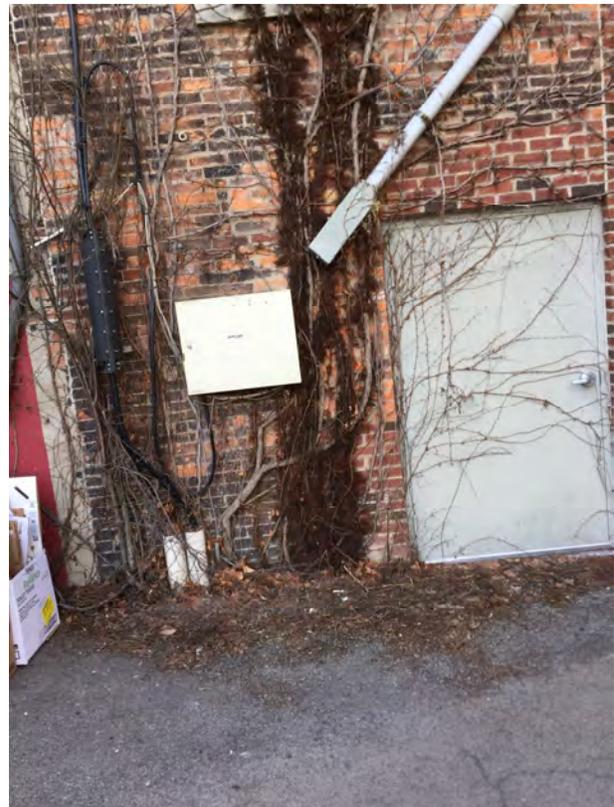
Figure 7 – East Wall, South Vines

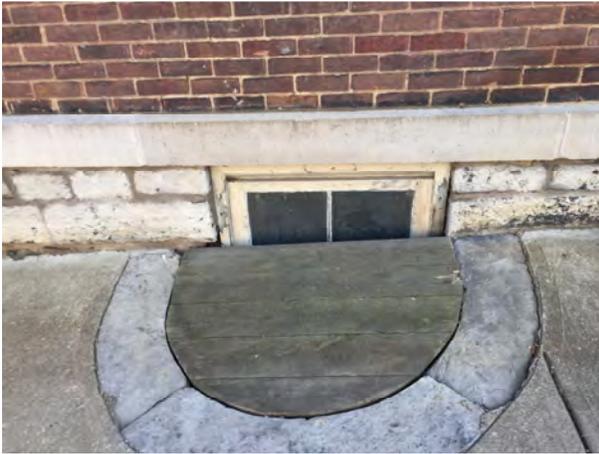
Figure 8 – North Basement Window Well

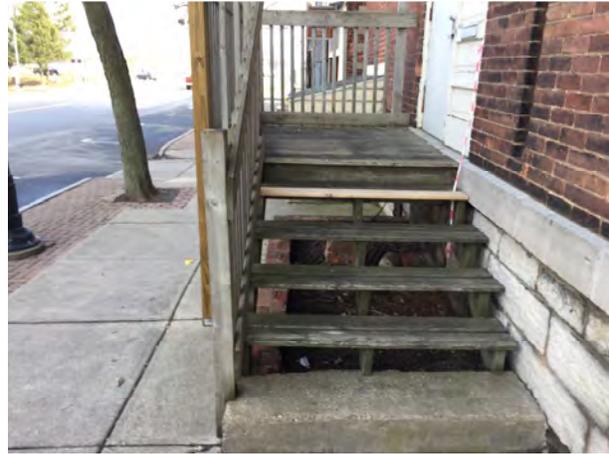
Figure 9 – North Center First Floor Frame Porch

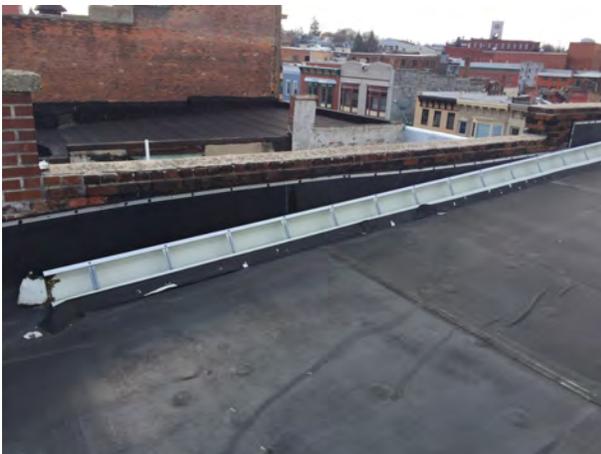
Several loose, abandoned items remain on the roof including an old aluminum gutter (south bay), satellite dish and concrete block (center bay). These items should be removed.

Figure 12 – South bay looking SW – abandoned aluminum gutter – compression bar termination.

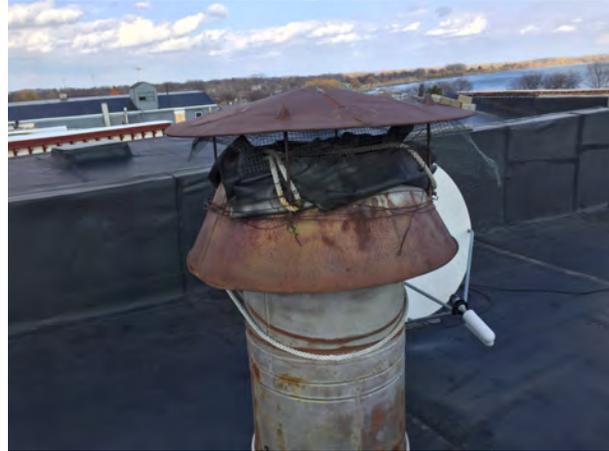
The original metal gravity vent in the center bay has had its opening stuffed with loose materials. These materials should be removed and a decision on how to address this original element made. It may be possible to incorporate it into a comprehensive ventilation plan. This will help identify an appropriate rehabilitation. Access to the roof is through a loose, manual wood hatch that is covered with EPDM

Figure 17 – Center bay abandoned vent.

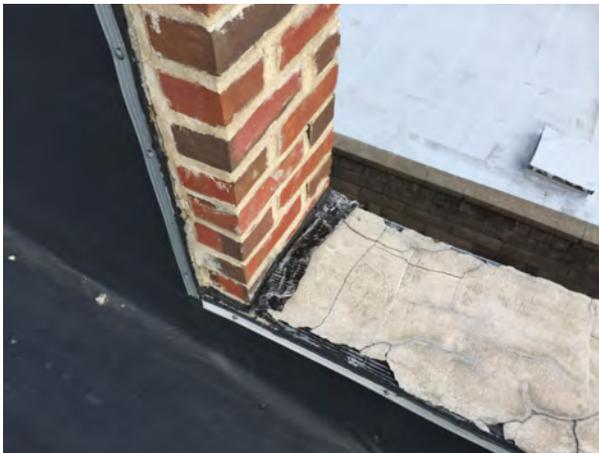
The south and east masonry parapet walls have a mortar wash sitting on impregnated copper mesh flashing. The mortar wash is showing signs of stress. Where masonry parapet walls step up the wall flashing has been turned up but is not adhered to the vertical surface or provided with cap flashing. The mortar wash should be replaced in the next five years and a metal counter-flashing installed at all vertical terminations.

Figure 16 – East parapet mortar wash and folded flashing.

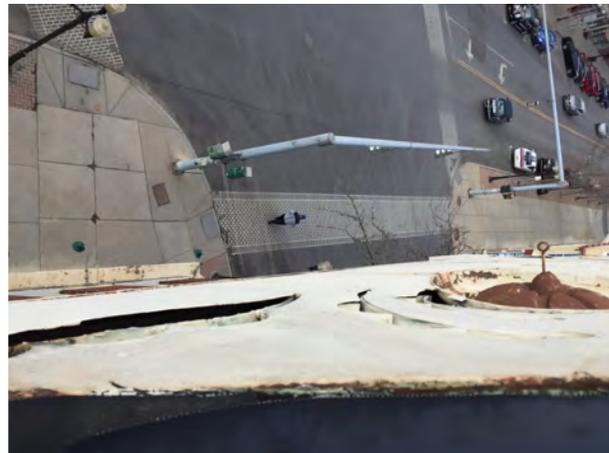
Figure 18 – West parapet sheet metal pediment – open metal seam.

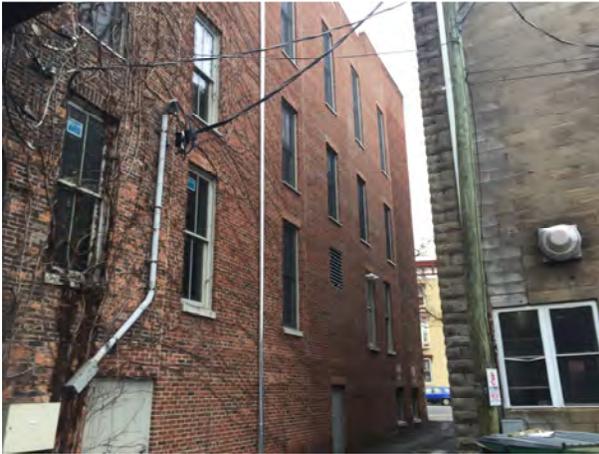
façade. As noted, a substantial portion of the rear, east, wall was rebuilt in 2007 with sympathetic brick and limestone. At that time deteriorated brick above the north side entrance was rebuilt.

Figure 21 – East façade with 2007 rebuilt brick wall

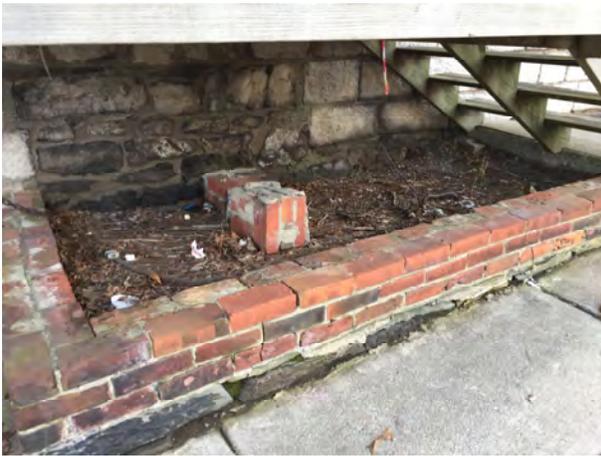
Figure 24 – Brick planter below side entrance porch

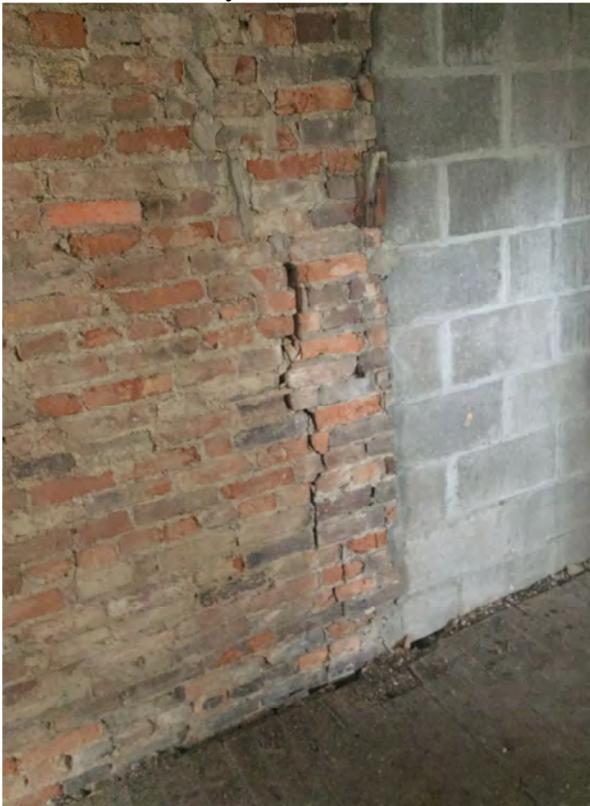
Figure 36 – 2nd floor interior brick bearing wall at CMU infill

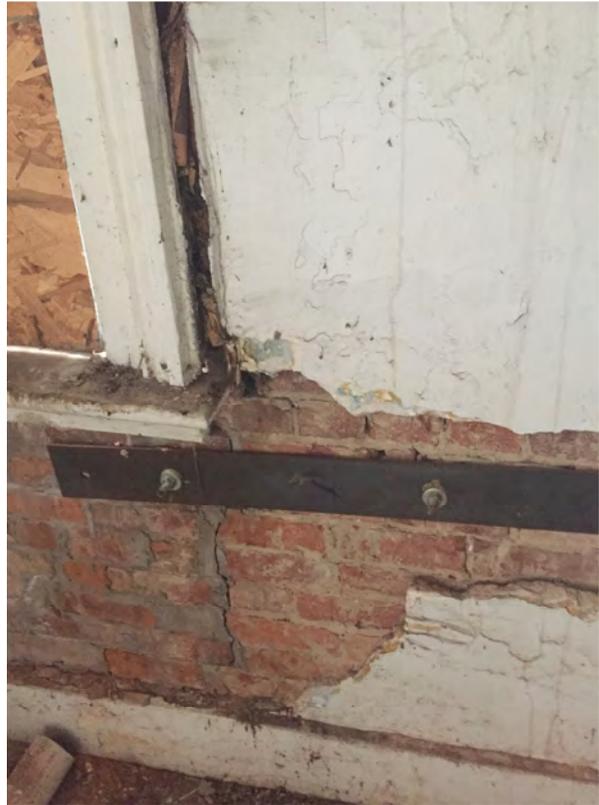
Figure 37 – NE exterior wall strapping reinforcement added in 2007

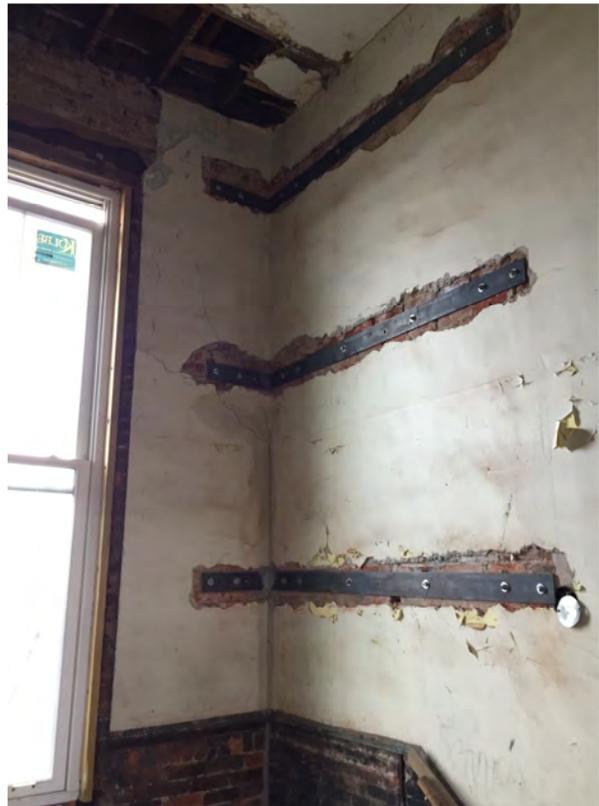
Figure 38 – 3rd floor SE exterior wall strapping reinforcement added in 2007

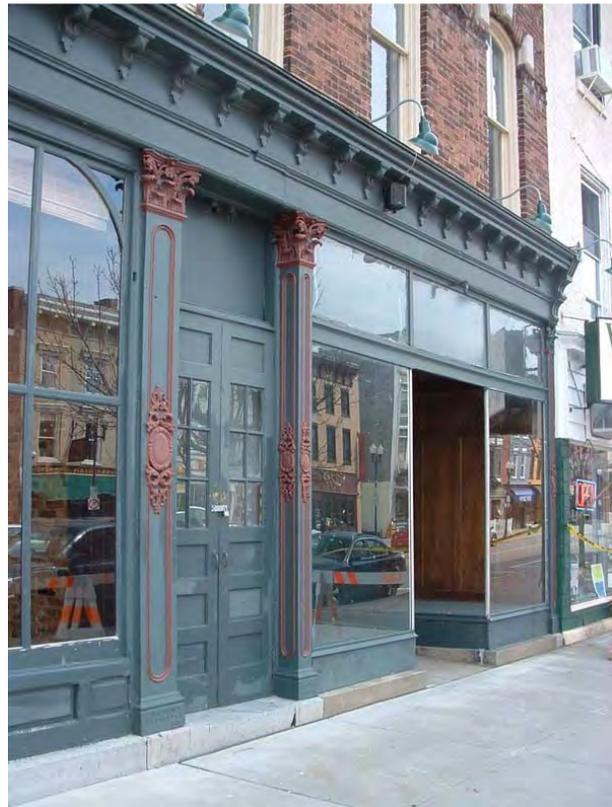
Elements of the original storefront construction and composition remain in the north and center bays. The south bay storefront display bulkheads, and display windows were replaced at some point with another traditional storefront style consisting of flush bulkheads, large glass display windows with a deeply recessed entrance, and a full width transom set above the entrance door, (likely in the 1920's or later). The south commercial bay did not have a separate entrance (refer to figures 49 and 62). You may want to consider an Optional rehabilitation project that restores the original cast iron columns and storefront elements to this commercial bay, with or without a separate entrance.

Figure 40 - West storefront with replaced south bay

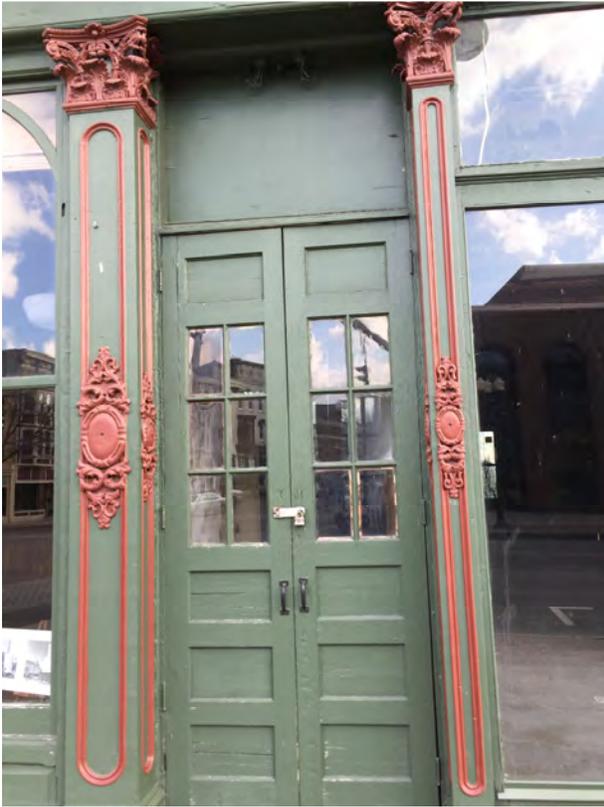
Figure 43 – West storefront cast iron columns

The West (front), NW cutaway corner, and the west portion of the north (side), storefront originally consisted of cast iron columns, large fixed glass display windows with short paneled bulkheads, topped off with a large wood sign band and decorative sheet metal cornice. All of these elements are in good condition with small areas of deterioration noticed. The cast iron columns were manufactured by the W.H. Cheney Company in Rochester, NY. All previously painted elements of the storefront should be prepped and painted.

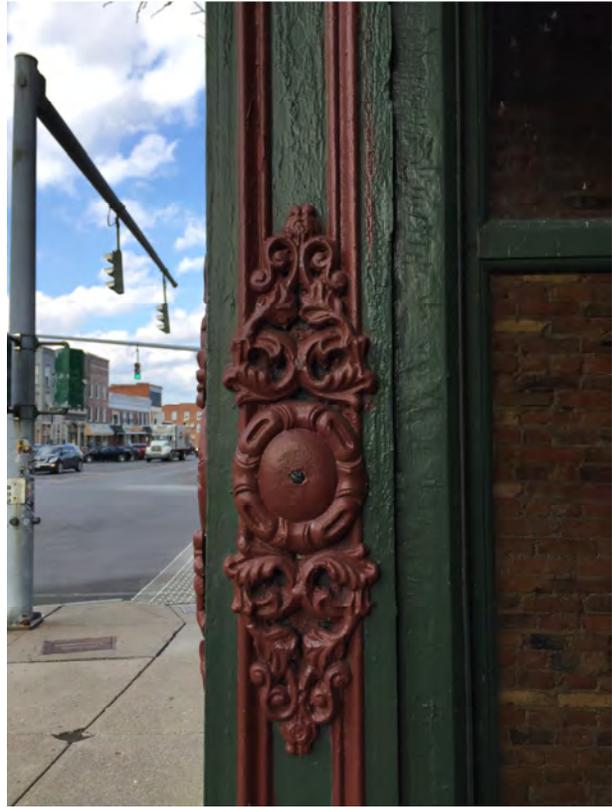
Figure 44 – West storefront cast iron column detail

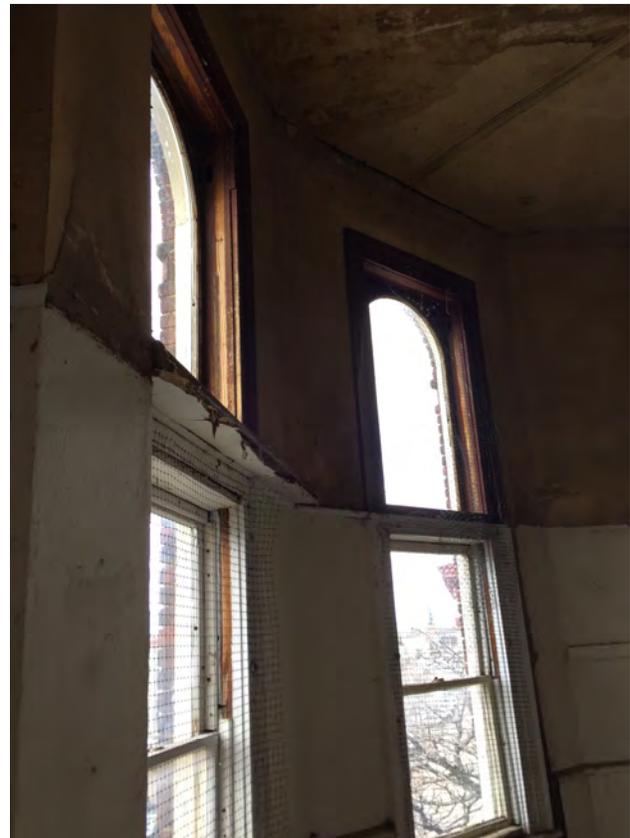
Original third floor windows were four over four, round arch head, double hung sash. When apartments were inserted in the large community space the lower sash were removed and replaced with shorter one over one double hung sash. The top of the new window and the bottom of the original upper sash formed the stop for a lowered apartment ceiling system. Most original upper sash remain with original muntins having been removed and multiple glass panes replaced by single panes. The original upper sash and new lower windows are in poor condition. Original and replacement sash at most openings on the east wall were destroyed prior to the east wall reconstruction project. The original openings were incorporated into the reconstruction project and new, painted wood, double hung windows installed. Except for the east wall windows installed in 2007, all sash should be removed and replacement wood, double hung, 2 over 2 simulated divided lite, arch head windows installed.

Figure 57 – 3rd floor windows

Several exterior wood sills on the second and third floors are deteriorated. Many interior stops are missing. Deteriorated sills should be replaced with a rot resistant wood such as American mahogany, white oak, cypress, or Spanish cedar, be prepared, primed with an oil-based primer, and painted.

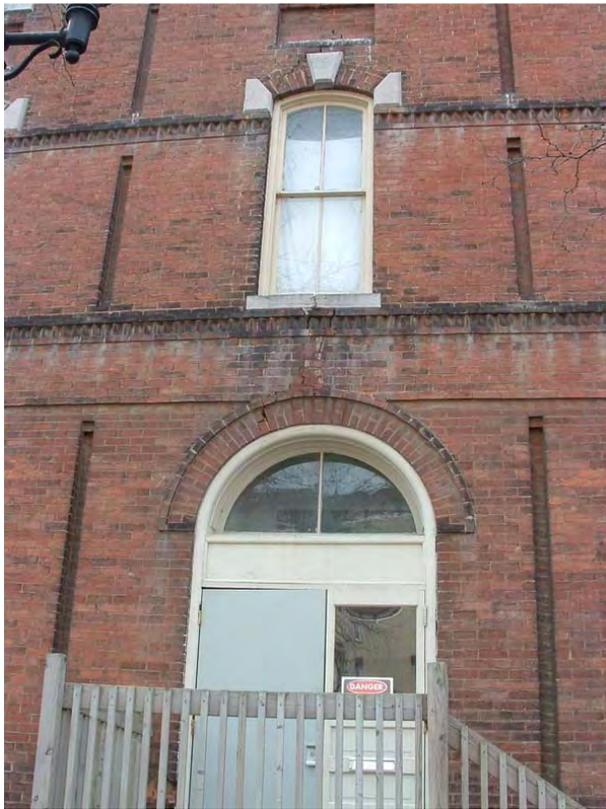
Figure 58 – North Façade First Floor Side Entrance

The north façade, first floor side entrance had a pair of original paneled wood doors below an arched transom. The east door was removed and a larger, modern, flush steel door installed. The remaining west paneled door has been cut down and remains as a fixed sidelite. Neither door is in good condition. Replace doors with single, larger painted wood panel door and one or two sidelites.

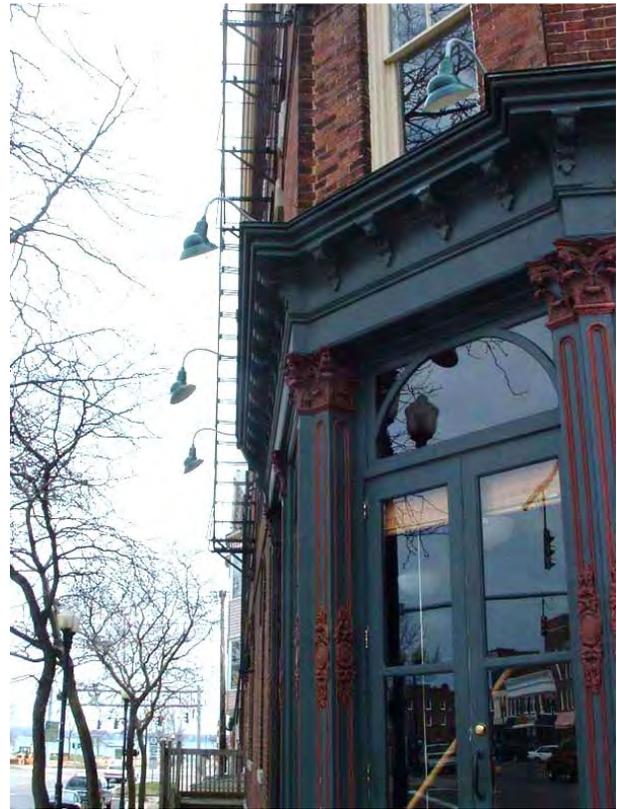
Figure 59 – Cutaway corner pair of doors

The cutaway corner has a pair of paneled wood doors with a full transom. The doors and transom are similar to the original but have likely been replaced when the transom had muntins added. These doors should probably remain fixed in place. They should be prepped and painted.

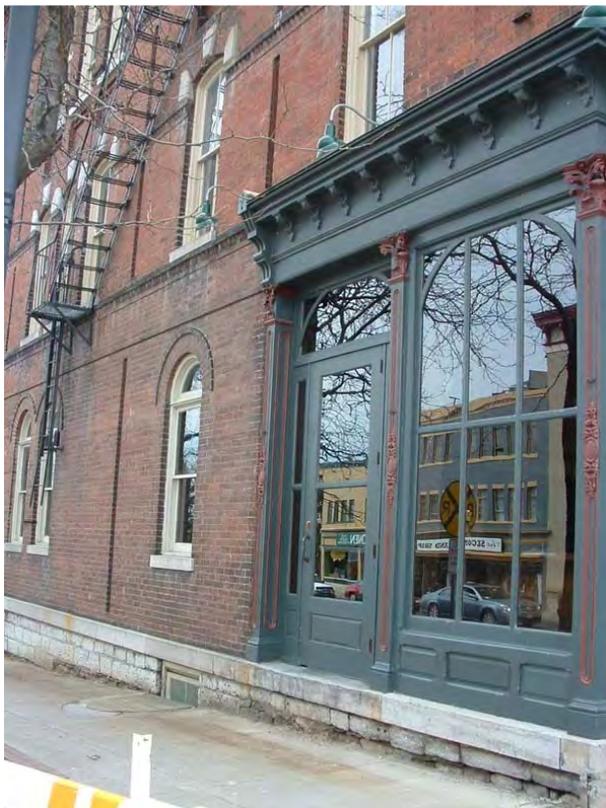
Figure 60 – North Façade Storefront replacement door with transom and sidelites

The north storefront would have had a pair of doors. A new, larger, single door with sidelites and a multi-pane transom has been installed. The west center bay had a pair of doors that have been replaced by a larger single door with a multi-pane transom. These storefront elements are in good condition and have a reasonable compatibility with the original storefront. They should be prepped and painted.

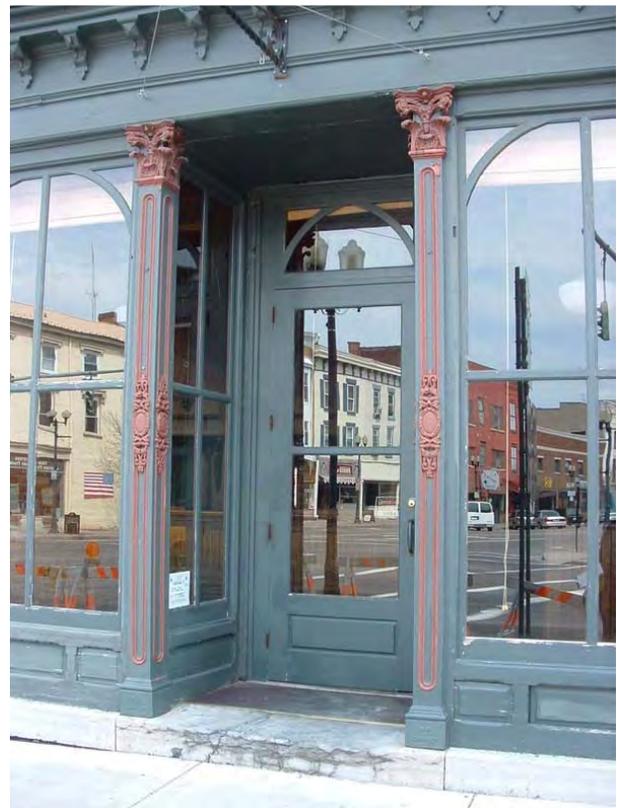
Figure 61 – West Storefront Center Bay replacement door and transom

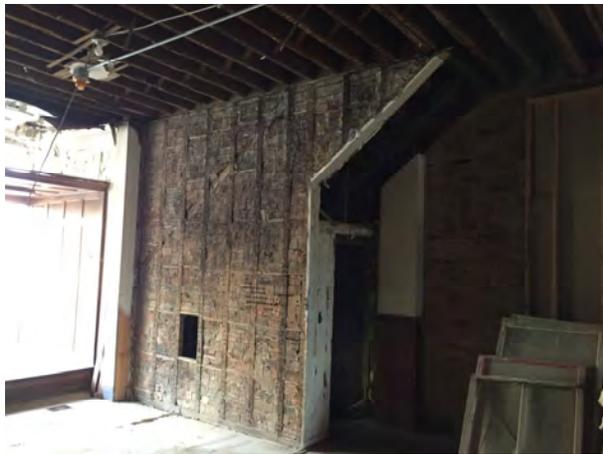
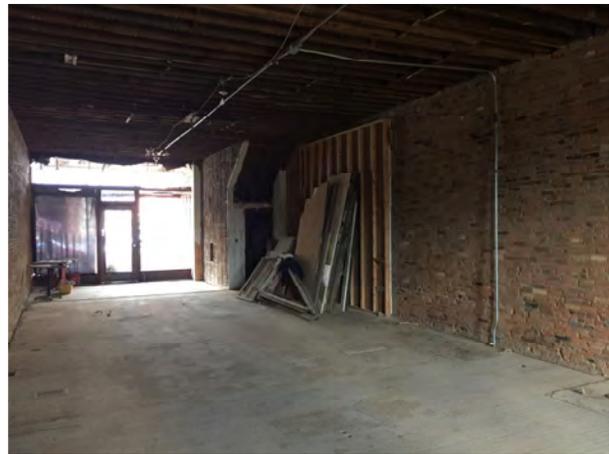
Figure 65 – 1st floor south bay looking NW

Figure 66 – 1st floor south bay looking west

The first floor south commercial bay has had all of the original wall and ceiling finishes removed exposing the brick walls and second floor framing. Wood wall paneling, part of the storefront replacement remains. A fire rated gypsum drywall ceiling system should be installed throughout (coordinate with supplemental structure). The south, common, brick wall should be furred out and finished with gypsum drywall. The stair to the basement, if it is to be retained, should be rehabilitated with a fire rated gypsum drywall system on both sides. The common brick wall to the center commercial bay should be left alone, to be developed when a tenant is identified.

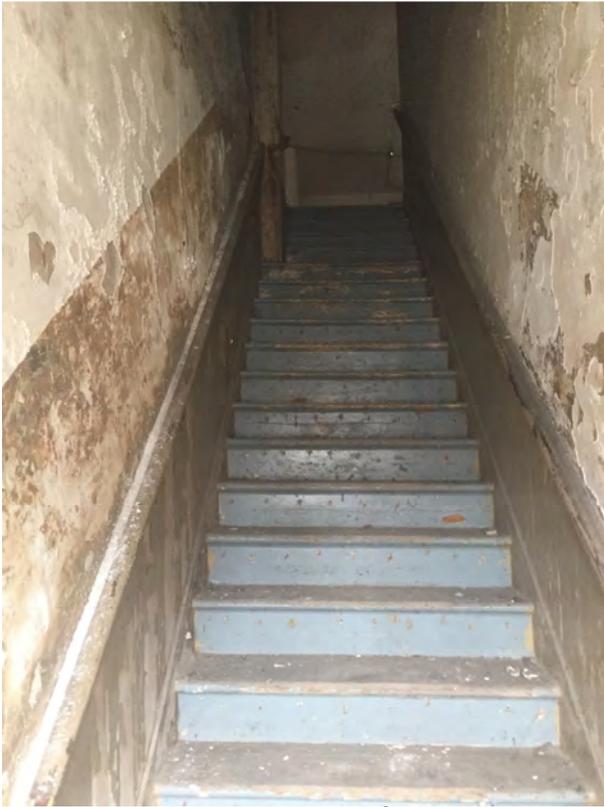
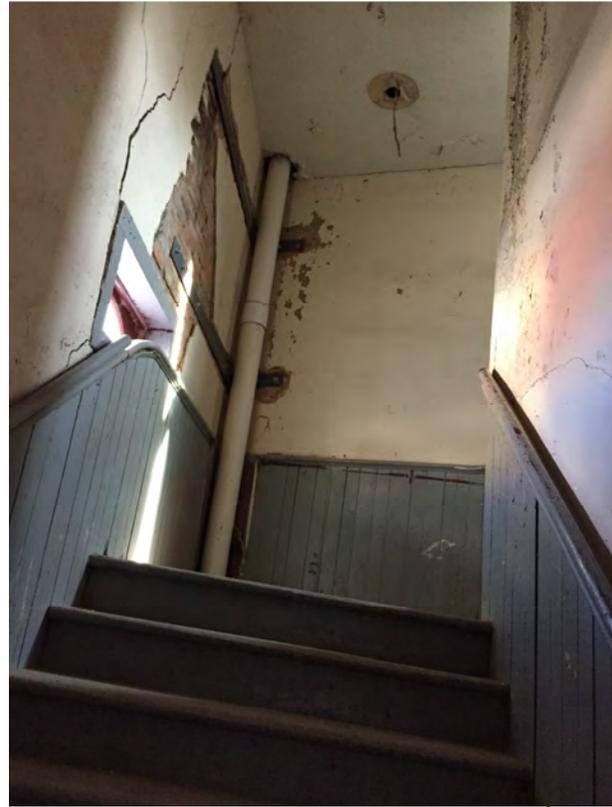
Figure 67 – 1st floor center bay 2nd floor stair from grade

Figure 68 – 1st floor NE stair to 2nd floor

The center stair from Exchange Street to the second floor and the NE stair from the north side entrance to the second and third floors have a wood board wainscot, simple bullnose chair rail, and plaster walls. The wainscot is in poor condition. The plaster is severely deteriorated in both locations. Salvage the wainscot and chair rail, remove deteriorated, fur out and provide gypsum drywall, rehabilitate and reinstall wainscot and chair rail, prep and paint.

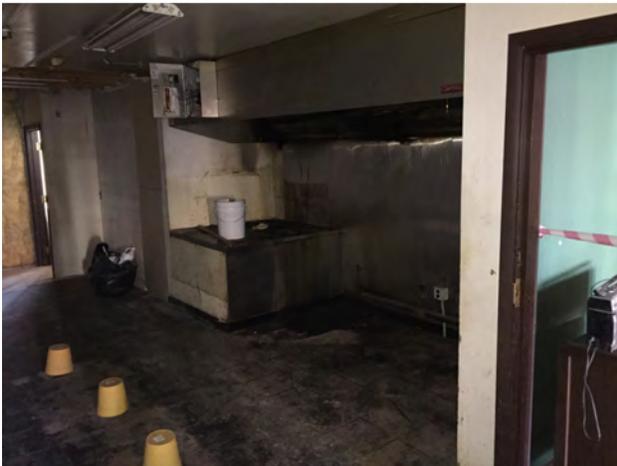
Figure 69 – 1st floor center bay east – abandoned kitchen

The kitchen and toilet rooms at the east end of the north and center bays have painted gypsum drywall ceilings and walls and vinyl flooring. These finishes are in poor condition due to leaks and associated damage from the rear wall reconstruction. A vestibule with gypsum drywall walls and ceilings was developed at the north side entrance and the vinyl flooring extended into it. These finishes are in poor condition. Remove the lowered ceiling, all gypsum drywall finishes, all flooring, and all equipment in the kitchen. The vestibule and toilet rooms should be left alone until a tenant for the first floor is identified.

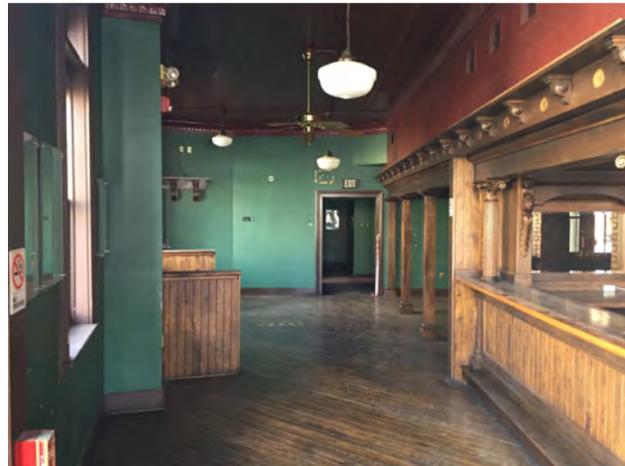
Figure 70 – 1st floor north bay looking east - bar

The bar area of the first floor has been built out in a traditional style with painted gypsum drywall, stained wood floors, painted-stamped metal ceiling, and stained wood bar and built-in seating elements. These finishes are in good condition. This area should remain intact until the needs of a new tenant are determined.

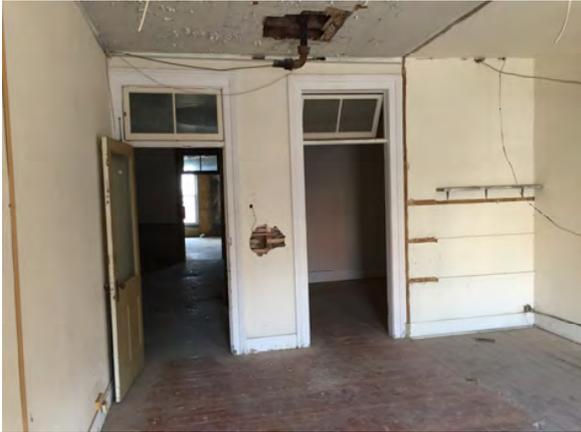
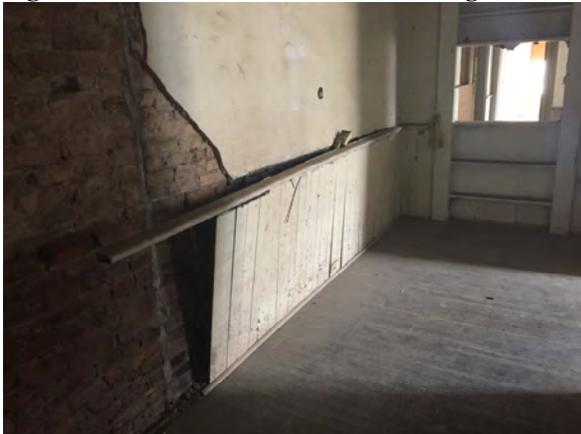
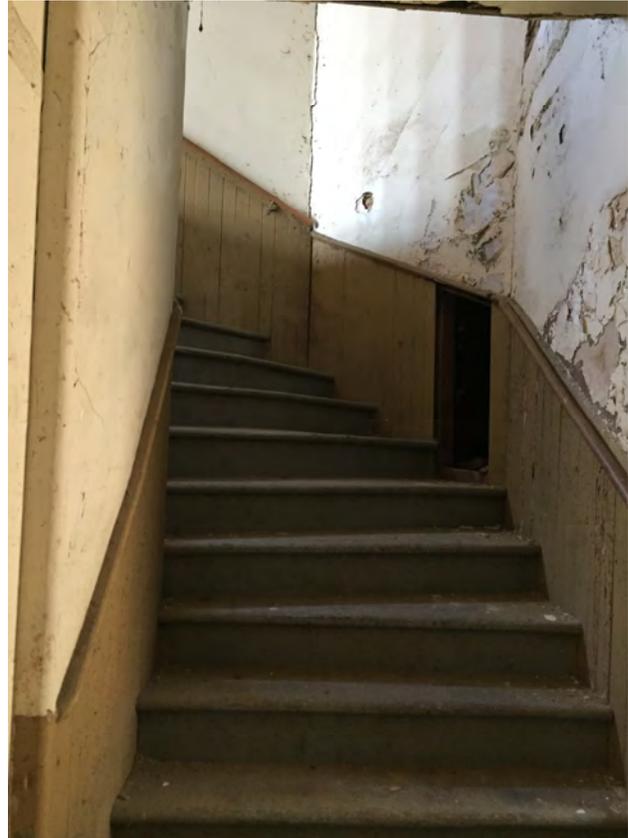
Figure 71 – 2nd floor SW bedroom looking east

Figure 72 – 2nd floor north bay-east looking west

Figure 73 – 2nd floor NE stair to 3rd floor

The second floor occupied rooms originally had plaster walls and ceilings, painted wood trim, and stained strip wood flooring. All finishes are in poor condition with areas of severe deterioration. One rear room has thin sheet wood wall paneling. Some of the floors have vinyl flooring or another layer of wood. Salvage wood trim and remove all plaster to brick or frame walls. Remove all non-original walls completely. Remove all non-original finish flooring. Provide a fire rated gypsum drywall ceiling system throughout (coordinate with supplemental floor structure). Fur out and provide gypsum drywall at exterior masonry walls. Interior, non-bearing frame walls should be left alone until the needs of a future tenant are determined.

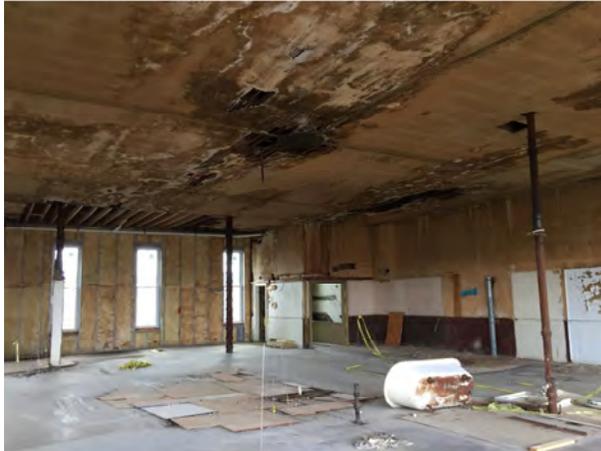
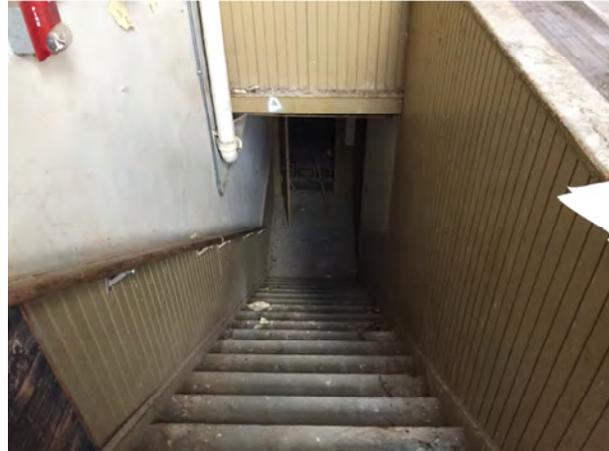
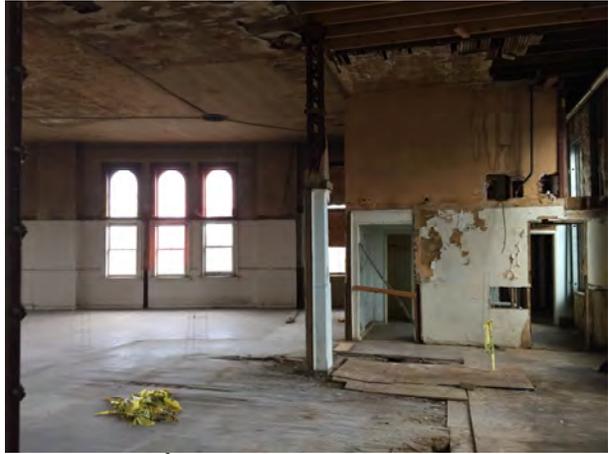
The third floor was originally one large, high ceiling community space with small enclosures at the NE and SE corners for stairs down. Finishes include stained wood flooring; painted wood trim, wainscoting and bullnose chair rail, painted plaster upper walls and ceiling. The plaster ceilings and walls are severely deteriorated. Much of the wood flooring is either severely deteriorated or warped due to previous leaks.

Figure 77 – 3rd floor south side looking NE

Figure 79 – 3rd floor SE looking west – stair to 2nd floor

Figure 80 – 3rd floor SE looking north

The SE stair, like the other stairs has a painted wood wainscot and bullnose chair rail with plaster upper ceiling and walls. A guardrail of the wood wainscoting is on the north side of the stair. Salvage chair rail finishes. Remove deteriorated plaster masonry wall plaster. Remove non-bearing wall construction. At the masonry walls, fur out and provide gypsum drywall, rehabilitate and reinstall wainscot and chair rail, prep and paint. New enclosure walls will be developed when a specific layout is identified.

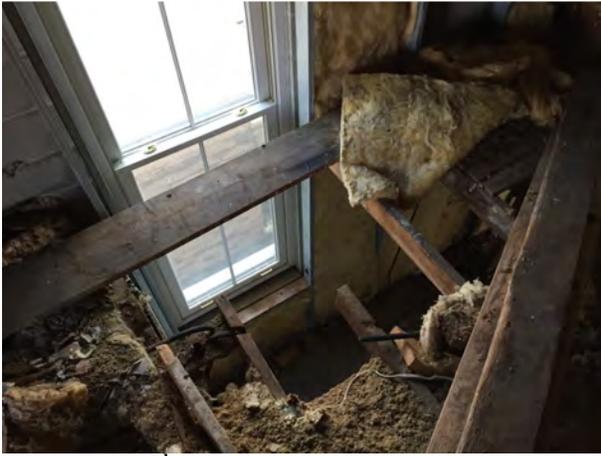
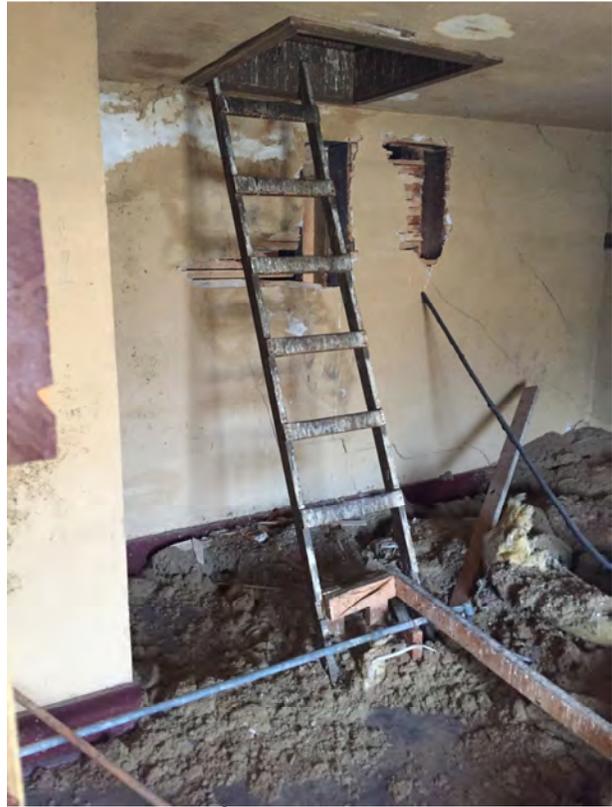
The NE rooms have a dropped ceiling forming a lower attic with a hatch to the attic below the roof. These rooms are severely deteriorated. Salvage chair rail finishes. Remove deteriorated plaster. Remove non-bearing wall and ceiling construction. At the masonry walls, fur out and provide gypsum drywall,

Figure 81 – 3rd floor NE stair attic floor

Figure 83 – 3rd floor NE stair attic – stair to attic

rehabilitate and reinstall wainscot and chair rail, prep and paint. New enclosure walls will be developed when a specific layout is identified. A fixed ladder access to the roof hatch will be required as part of any future rehabilitation.

There are several areas of severely deteriorated finish wood flooring and sub-flooring. Areas of deteriorated flooring should be cut back, in rectangular sections, to sound original material. Replacement sub-flooring should be installed in these areas.

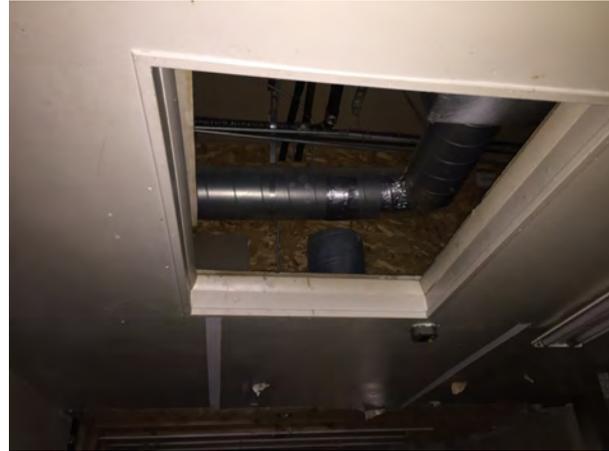
Figure 87 – 1st floor kitchen lowered ceiling hatch – where there is abandoned equipment
